Stage 1 Road Safety Audit

BusConnects Core Bus Corridors
- Blanchardstown to City Quays

Document Ref: P20-138-PSW1-RP-001

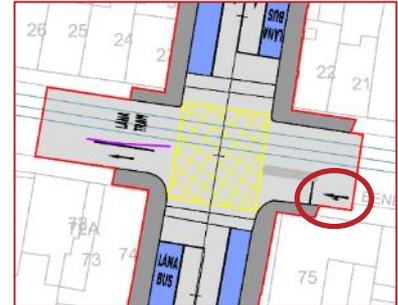
At a number of signalised junctions within the Scheme including, but not limited to, those listed above, the movements permitted at the junctions, as indicated by arrow roadmarkings on the drawings are not reflected in the movements indicated within the proposed signal phasing diagrams. For example, in some cases, right turns are indicated in the phasing diagrams while the arrow roadmarkings indicated on the drawings permit only straight-ahead and left turning movements.

This could lead to inconsistencies between the information provided to drivers by the signal heads and the arrow roadmarkings resulting in driver confusion and the potential for drivers undertaking prohibited movements at signalised junctions increasing the risk of collisions with other road users.

Recommendation

Ensure the movements permitted in each phase at signalised junctions reflects the movements indicated at the junction. This may require amending the signal phases or amending the roadmarkings at junctions such that drivers are sufficiently aware of all permitted movements at junctions.

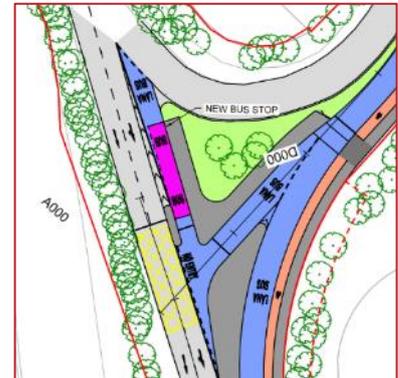
A new bus stop has been indicated on the N3 northbound off slip at junction 3 between the left-turn slip lane at the entrance to the Blanchardstown Shopping Centre and the exit from the bus lane exiting the Blanchardstown Shopping Centre.

Drivers following buses on the off-slip may be insufficiently aware of the commencement of the bus lane downstream and follow the bus into the bus lane resulting in sudden weaving manoeuvres into the adjacent lane and side swipe collisions with adjacent vehicles or collisions with the physical island at the stop line.

Also, it is unclear if there will be sufficient space available for buses exiting the bus stop and re-entering the traffic lane on the off slip between the two physical islands. If sufficient space is not provided there is a risk of kerb strikes and material damage as a bus leaves the bus stop.

Recommendation

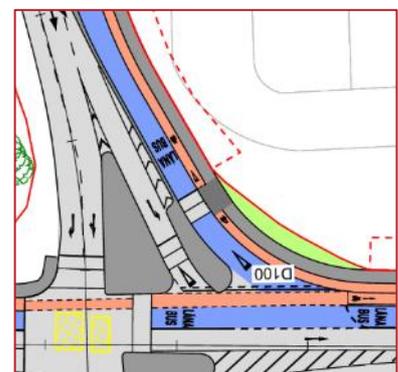
Should insufficient inter-green time be allowed in the signal phasing to permit slower moving cyclists to clear the entire junction, visibility for a bus driver exiting onto Blanchardstown Road South towards a westbound cyclist may be restricted by a high-sided vehicle at the other exit leading to buses turning left onto Blanchardstown Road South when it is unsafe to do resulting in collisions.

Additionally, a driver of a private vehicle at the Yield line will be focussed on traffic approaching from their right when exiting and may not take due care and attention to a bus at the adjacent exit. This could lead to a driver turning left onto Blanchardstown Road South when a gap in traffic becomes available at the same time as a bus exits the adjacent access resulting in a risk of side swipe, or rear end shunt, collisions with an exiting bus.

Recommendation

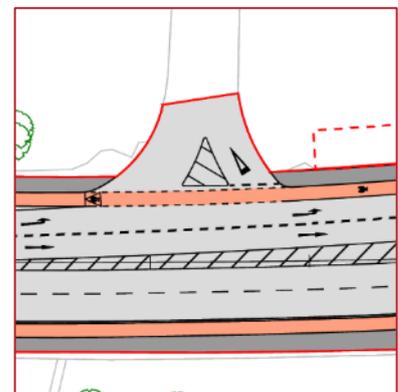
It is unclear from the drawing provided if it is proposed to retain the pedestrian crossing at this location. If a crossing is not retained at this location mobility impaired pedestrians may be unable to safely and independently access the footpath downstream while visually impaired pedestrians may be insufficiently aware of the access and inadvertently enter the carriageway where there is an increased risk of being struck by a vehicle.

Additionally, the existing physical island at the access is indicated as being removed and a hatched island provided in its place which may result in a lengthy crossing for VRUs without a sufficient area to take refuge. Removing the physical island from this location may lead to drivers turning right out of the access where there is an increased risk of collisions with vehicles on retail park within the Blanchardstown Road South.

Recommendation

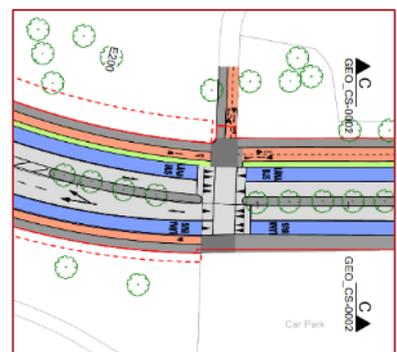
There is an existing signalised crossing of the access road to the Blanchardstown Shopping Centre which is proposed to be retained. Trees have been indicated within the central median to the east and west of the crossing. The location of the trees may lead to a driver's visibility towards the traffic signals at the crossing being obscured. This could lead to drivers being insufficiently aware of a red signal at the crossing resulting in them failing to moderate their speed and stop at the stop line resulting in overshoot of the stop line and an increased risk of collisions with pedestrians using the crossing.

Similarly, a bus using the bus lane may restrict a driver's visibility to the nearside signal head leading to the same issue described above.

Recommendation

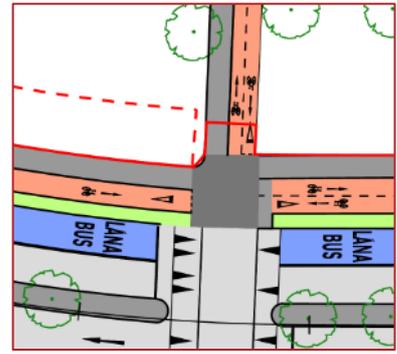
The one-way eastbound cycle track on the northern side of the access road to the Blanchardstown Shopping Centre terminates at a shared surface at the signalised crossing. The two-way cycle track on the same side of the access road terminates on the opposite side of the shared surface at this location. The cycle tracks are aligned such that the eastbound one-way cycle track is directly opposite the westbound cycle track.

This could lead to cyclists travelling in either direction being insufficiently aware that the downstream cycle track is for the opposing direction resulting in them entering the cycle track where there is an increased risk of head-on collisions with opposing cyclists.

Recommendation

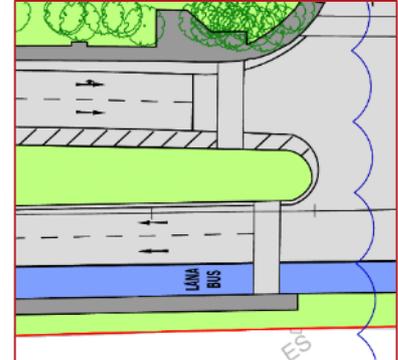
A two-stage staggered pedestrian crossing has been indicated across the N3 on the western arm of the Navan Road/Connolly Hospital Access (Northbound) junction. There is currently no footpath provided in the median verge and one has not been indicated on the drawings provided. A failure to provide a footpath through the central median verge linking the pedestrian crossings will lead to pedestrians having to travel within the grassed median where there is a risk of slips, trips and falls during wet weather.

Similarly, mobility impaired pedestrians, particularly wheelchair users, may experience difficulty in traversing the grassed median and visually impaired pedestrians may be unable to locate the downstream crossing. This will result in visually, and mobility, impaired pedestrians being unable to safely, and independently, navigate the road layout.

Recommendation

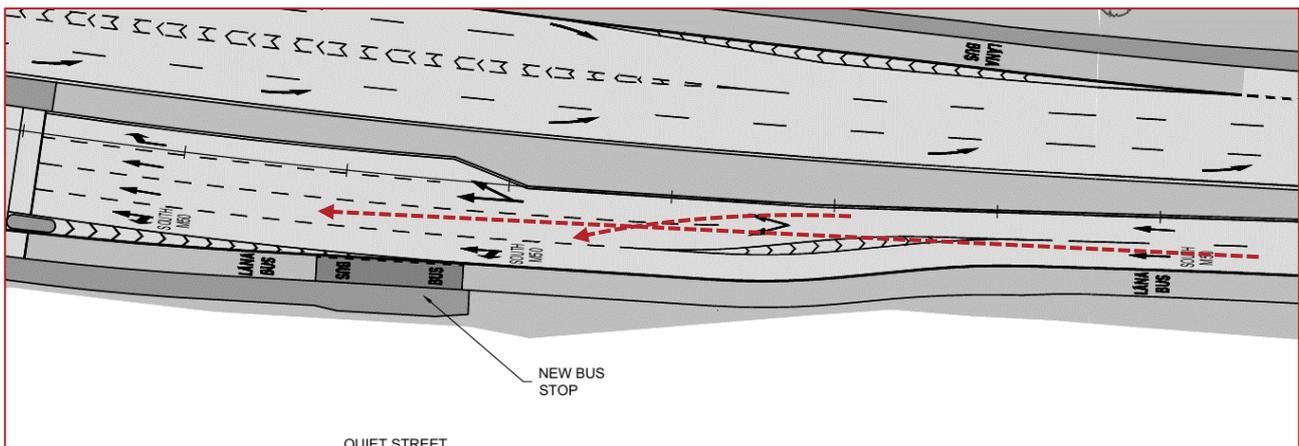
The proposed road layout on the N3 westbound carriageway approaching the intersection with Auburn Avenue & Dunsink Lane requires vehicles in the nearside traffic lane to move left, while the offside lane splits into two straight-ahead lanes and one right-turn lane.

This arrangement is conveyed via a hatched roadmarking. There is a concern that drivers in the nearside lane may fail to observe the direction to move left, in particular as the hatched roadmarkings may fade over time, leading to potential side-swipe collisions with vehicles from the offside lane moving into the centre straight-ahead lane.

Recommendation

It is recommended that the nearside lane at this location proceed straight-ahead, with a new lane developed on the left-hand side catering for traffic wishing to access the M50 southbound or to turn left onto Auburn Avenue.

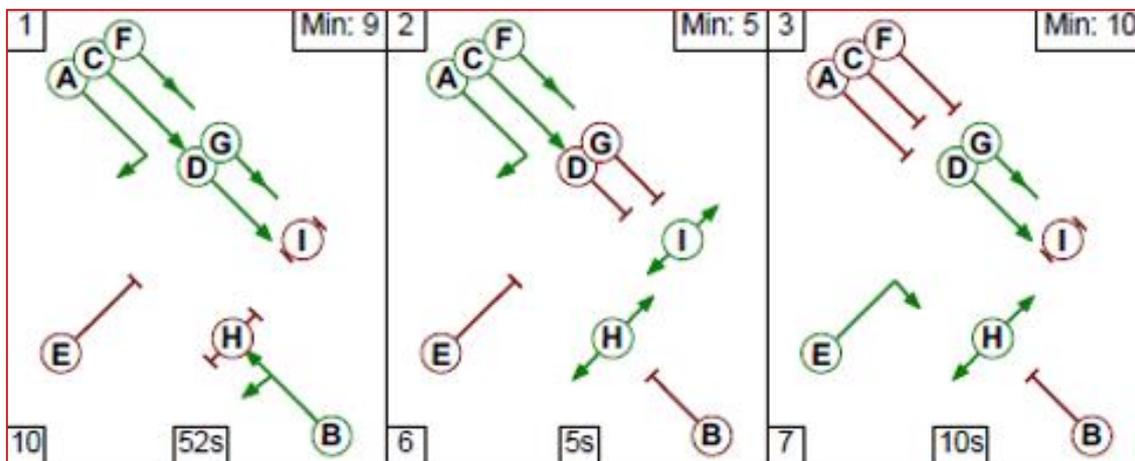
The signal phasing diagrams provided for the Aughrim Street/Manor Street junction do not appear to match the layout indicated on the drawings provided. A single southbound lane is indicated on Manor Street to the north of Aughrim Street which directs traffic, with the exception of buses, taxis and cyclists, to turn right into Aughrim Street where a right turn lane is provided. Further south of the right turn lane a southbound bus lane and cycle track develop. Similarly, travelling northbound, traffic, with the exception of buses, taxis and cyclists, is directed to turn left into Aughrim Street while a northbound bus lane develops downstream and cyclists transition from the cycle track onto the carriageway.

It is also unclear from the drawings provided if a sufficient amount of time will be provided between Phases 2 and 3 to allow vehicles entering Aughrim Street to clear the one-way section before contraflow buses are given a green signal. If sufficient time is not allowed between these phases there is a risk of buses proceeding while vehicles continue to enter Aughrim Street where there is a risk of head-on collisions or unsafe reversing manoeuvres back along Aughrim Street, or back onto Manor Street, resulting in an increased risk of rear end shunt collisions.

Recommendation

While the Audit Team do not consider the layout of the junction to be unsafe in principle, the signal phasing should be further reviewed and refined to ensure it sufficiently reflects the layout proposed and does not result in conflicting movements operating during the same phase.

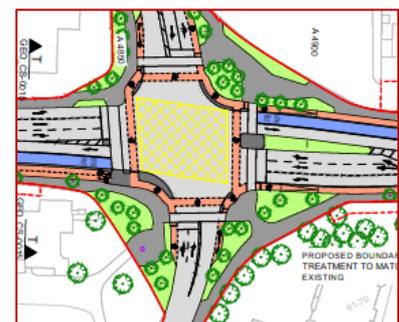
It is proposed to remove the Ashtown Roundabout and provide a signalised junction in its place. However, the widths of the proposed pedestrian crossings at the signalised junction appear to be quite narrow relative to other crossings within the Scheme. This may lead to these crossings failing to sufficiently accommodate the volume of pedestrians and cyclists at this location resulting in potential conflicts.

Recommendation

Ensure the pedestrian crossings are sufficiently wide enough to accommodate the expected volume of pedestrians, noting that DMURS recommends at least 4m wide crossing widths in urban areas.

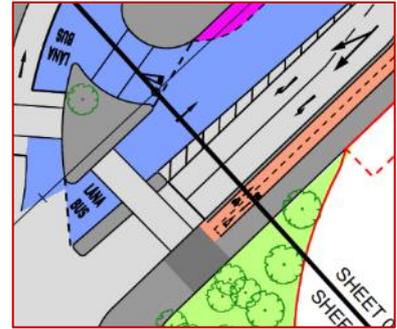
- 4.2 Existing bus stops (No. 1697 & 1665) located on both sides of the Navan Road at Darling Estate have been indicated as being relocated however their proposed locations have not been indicated on the drawings provided. It is therefore unclear if the proposed relocated bus stops will be provided at safe locations such that they do not present hazards to drivers or impede a driver's visibility towards signs, signals and vulnerable road users. Ensure these bus stops are located where they will not result in hazards to other road users.

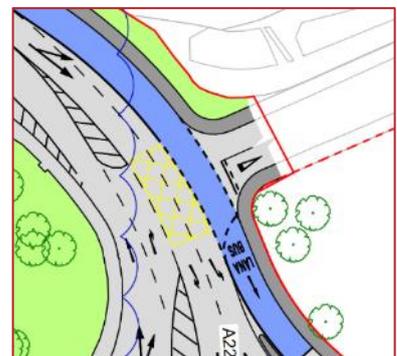
4.6 There is an existing gated delivery entrance on the southern side of the carriageway to the west of the proposed signalised junction at the Crowne Plaza Hotel in the Blanchardstown Shopping Centre. This delivery access has not been indicated on the drawings provide and it is therefore unclear if it is proposed to retain this entrance. If this entrance is to be removed an alternative delivery entrance may be required. Measures should be provided within the Scheme to facilitate deliveries at this location.

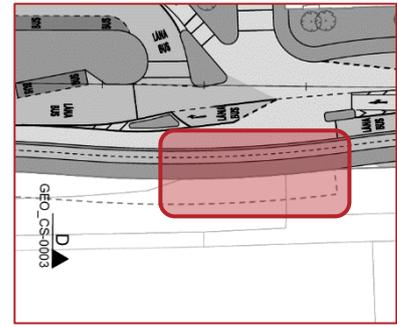
4.7 During the site visit, the Audit Team noted that a new service station is currently under construction on the southern side of the Old Cabra Road adjacent the Earls Court residential development. This service station has not been reflected in the proposed design at this location. The access/egress to this service station will require crossings of the proposed footpath and cycle track at this location. Measures should be provided in the Scheme to accommodate safe entry and exit to this future service station.
