## **Appendix A12.2** Aquatic Baseline Report

# Aquatic baseline report for the BusConnects Dublin – Core Bus Corridor Infrastructure Works

Prepared by Triturus Environmental Ltd. for Scott Cawley

**December 2020**

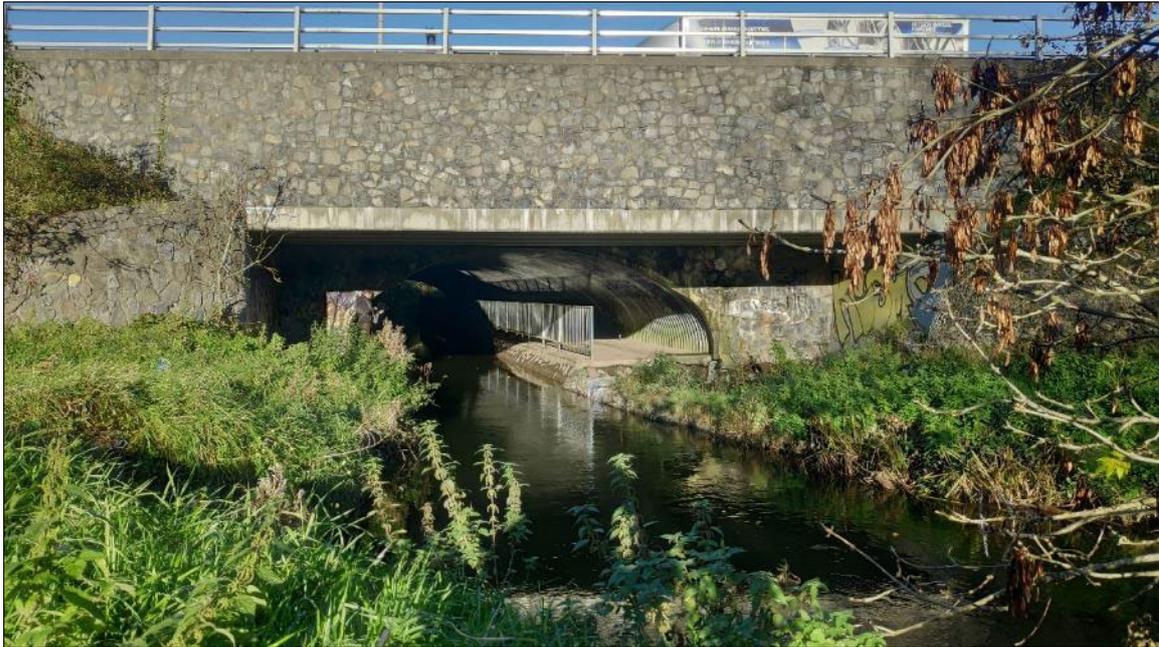
The River Tolka at site T1 was a semi-natural lowland depositing watercourse (FW2) with evident historical deepening and bank modification works. These included gabion basket scour protections and a concrete culverted bed at the N3 road crossing. The river profile mainly comprised of deep glide (60% area) and pool (30%) with more localised riffle (10%). The channel averaged 5-8m wide, with a variable depth of 0.3-1.5m deep. The channel bed comprised rendered concrete under the road crossing. However, downstream of the culvert, the substrata were dominated by boulder and cobble with pockets of very localised medium and fine gravels. The substrata were heavily bedded with 30% cover of filamentous green algae, indicating enrichment. The bed suffered from heavily siltation, albeit swift flows reduced the visible deposition levels on instream substrata. The macrophyte community was limited to small patches of emergent branched-bur reed (*Sparganium erectum*) and watercress (*Rorripa nasturtium-aquaticum* agg.). The coarse substrata on the bed also supported the aquatic moss species *Cinclidotus fontinaloides* and *Platyhypnidium riparoides* locally. The riparian habitats supported mainly scrub habitat (WS1) and rank grassy areas (GS2) with frequent nettle (*Urtica dioica*), butterbur (*Petasites hybridus*), thistles (*Cirsium* spp.) and red osier dog wood (*Cornus cericea*). Riparian trees were scattered along the banks with crack willow (*Salix fragilis*) and sycamore (*Acer pseudoplatanus*) being the most frequent species.

The river was considered a moderate quality brown trout nursery, with some localised deeper pools (including immediately downstream of the culvert) providing good holding habitat. Spawning habitat for both salmonids and lamprey was locally good (c.110m downstream of the culvert in the tailing of a pool where mobile gravel was identified, ITM 707825, 738930). The site offered poor lamprey ammocoete habitat given the high flow rates and predominance of hard substrata. European eel habitat was moderate overall. The deeper pool areas locally would support European eel (*Anguilla anguilla*). White-clawed crayfish are not present in the River Tolka (no known records) and were not recorded during the survey. Otter spraint (1 site (3 spraints)) was recorded under the culvert in a muddy area of the west bank (ITM 707817, 739019).

**Plate 3.1** Representative image of site T1 on the River Tolka (facing upstream towards culvert)

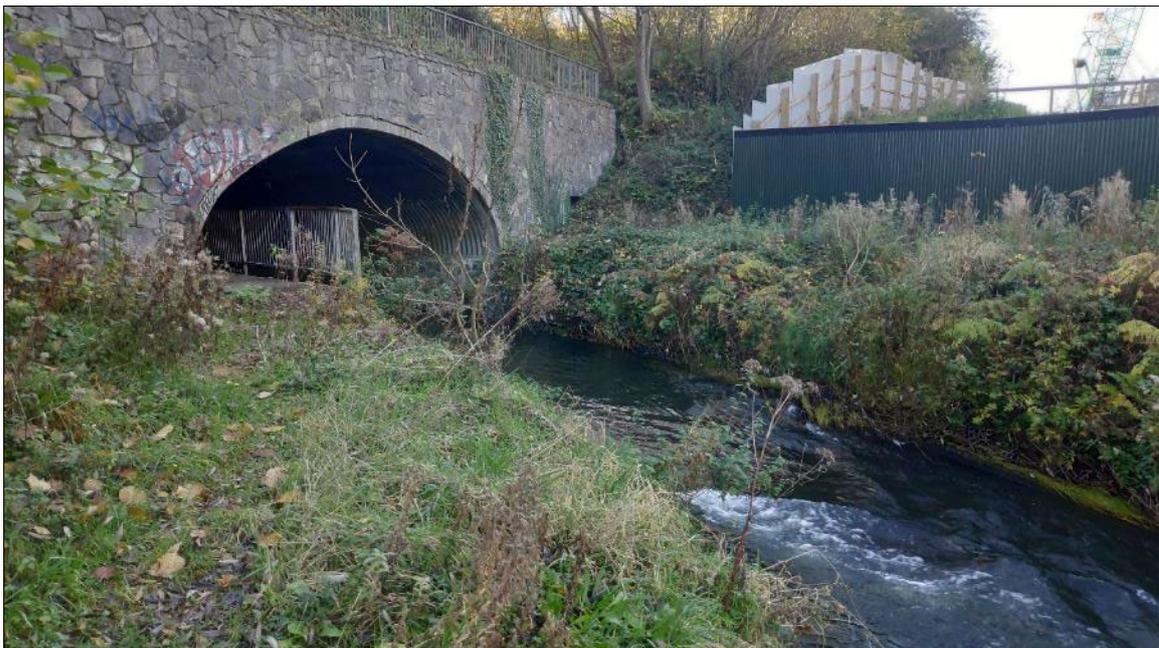
The River Tolka at site T2 was a semi-natural lowland depositing watercourse (FW2) with a swift flow and a well-defined thalweg downstream of the bridge crossing and associated culvert. Located approx. 0.5km downstream of site T1, the river profile was dominated by glide (50%) and riffle (40% area) with more localised pool 10%. The channel width was variable between 6m and 14m wide. The depth was also variable and recorded between 0.4m and 1.0m deep. The good semi-natural character for an urban river, however, was diminished by riverine substrata that were in poor condition due to siltation pressures. Furthermore, hydro-morphologically the river had been altered at the N3 crossing with the channel bed comprising of rendered concrete with little gravel or cobble deposition under the road crossing. Downstream of the culvert, the bed comprised bedrock, boulder and cobble with very localised pockets of medium and fine gravels. The substrata were very however, heavily bedded and covered by filamentous green algae (205 surface area cover, indicating enrichment). While the bed suffered from heavily siltation, the swift flows reduced the visible deposition levels on the visible instream substrata (as with other areas on the River Tolka). The macrophyte community comprised locally frequent watercress (*Rorippa nasturtium-aquaticum* agg.) and lesser water parsnip (*Berula erecta*) in the margins. The coarse substrata on the bed also supported *Cinclidotus fontinaloides* and *Platyhipnidium riparoides* locally. The riparian habitats supported mainly scrub habitat and rank grassy areas with frequent winter heliotrope, nettle, bramble (*Rubus fruticosus* agg.), bracken (*Pteridium aquilinum*), buddleja (*Buddleja davidii*), hemp agrimony (*Eupatorium cannabinum*), spear thistle (*Cirsium vulgare*) and hogweed (*Heracleum sphondylium*). The banks supported a few scattered mature crack willow (*Salix fragilis*), with a more mature treeline downstream of the survey area. The river upstream of the culvert was narrower, very fast flowing and heavily overgrown with scrub. Historical bank works were evident with gabion baskets present.

The river was considered a moderate brown trout nursery, with some localised deeper pools providing good holding habitat. Spawning habitat for both salmonids and lamprey was poor given substrata compaction and bedding. Swift flows largely precluded sediment deposition but some superficial silts were present marginally which provided some limited suitability for *Lampetra* sp. ammocoetes. European eel habitat was moderate overall albeit compaction of the bed and swift flows provided for less optimal refugia. White-clawed crayfish are not present in the River Tolka (no known records) and were not recorded during the survey. Regular otter spraint sites were recorded on the concrete path on the downstream side (ITM 708122, 738814) and upstream side of the culvert (ITM 708095, 738790).

**Plate 3.2** Representative image of site T2 on the River Tolka (facing upstream towards culvert)

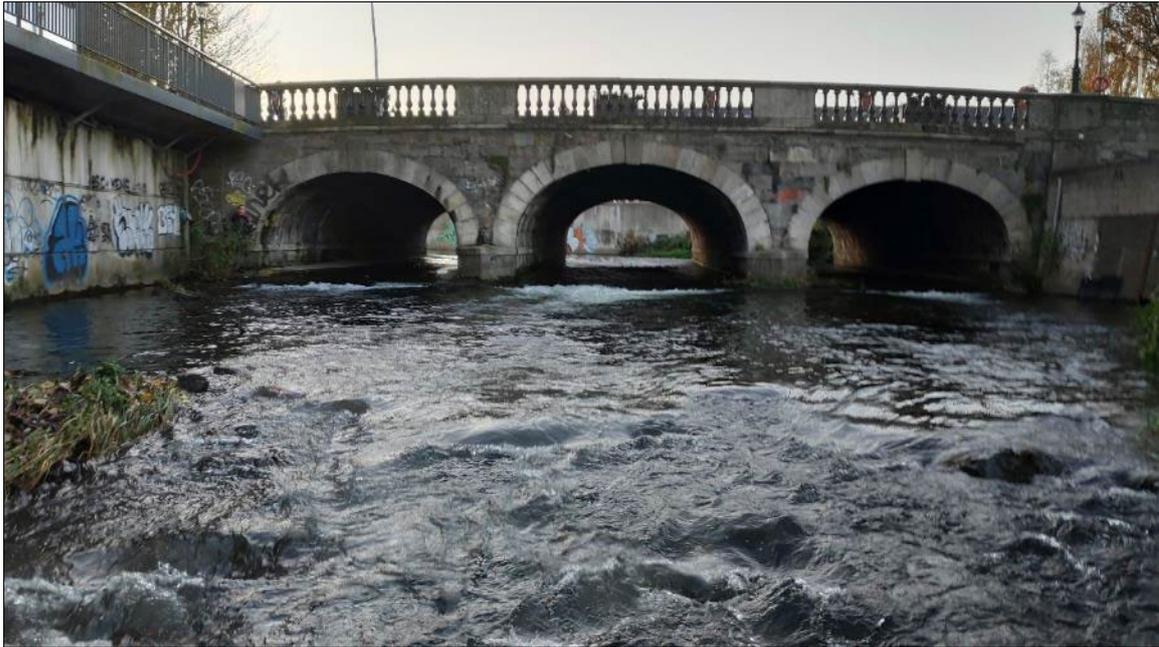
The River Tolka at site T3 was a semi-natural lowland depositing watercourse (FW2) with a swift flow. Despite being located in a heavily urbanised area with high retaining walls, the river profile was surprisingly natural downstream of the bridge (upstream being glide dominated, held between retaining walls and with less natural character). The river profile was dominated by glide (30%) and riffle (50%) with more localised pool 20% (the largest of which was located immediately downstream of the bridge apron/weir). The channel width was variable between 15m and 20m wide, being narrower downstream where marginal riparian stands of osier (*Salix viminalis*), grey

Downstream of the bridge, the river was considered a good brown trout nursery and good holding area for adult fish. Spawning for both salmonids and lamprey was considered locally good, despite siltation pressures. Upstream of the bridge the river was mainly a holding area for salmonids with deeper glide habitat held between retaining walls. Lamprey ammocoete habitat was sparse given the high energy nature of the site. European eel habitat was good downstream of the bridge owing to ample boulder refugia and deeper pool areas. White-clawed crayfish are not present in the River Tolka as previously described for other survey areas and none were recorded during the survey. A regular otter spraint site (1(6), mixed age) was recorded on the bridge apron downstream of the bridge (south bank) (ITM 716124, 736756).

**Plate 3.3** Representative image of site T3 on the River Tolka at Frank Flood Bridge (facing upstream)

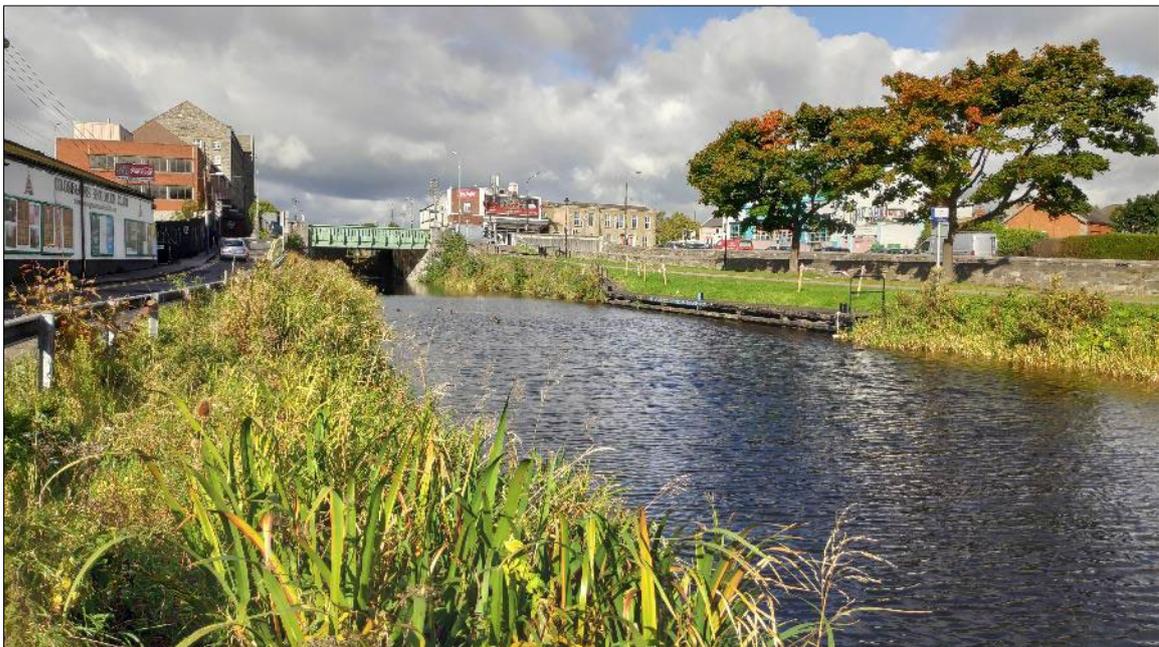
The Royal Canal between the 4<sup>th</sup> and 5<sup>th</sup> lock (level 4, Phibsborough) was a uniform 10-12m wide and 1.5-2.5m deep, with a centrally deeper navigation channel in most areas. The substrata were dominated by silt with high clay fractions (often >0.3m in depth), with scattered boulder and localised marginal cobble/gravel areas (e.g. along boat gangway). The 300m section of canal (between the 4<sup>th</sup> and 5<sup>th</sup> locks) was typified by narrow riparian fringes bordered by urban areas and built land (BL3). The riparian zones supported a range of common species such as great willowherb (*Epilobium hirsutum*), nettle, meadowsweet, yarrow (*Achillea millefolium*), marsh ragwort (*Jacobaea aquatica*), hedge bindweed (*Calystegia sepium*), creeping thistle, hogweed and occasional teasel (*Dipsacus fullonum*). Non-native Canadian fleabane (*Conyza canadensis*) and buddleja were both occasional. Intermittent planted treelines of sycamore and cherry (*Prunus* sp.) were present in maintained grassland strips (WD5 parkland habitat). The canal margins were lined by narrow linear strips dominated by reed sweet grass (*Glyceria maxima*) with frequent stands of iris (*Iris pseudacorus*) and occasional reed canary grass. Instream, the macrophyte community was dominated by yellow lily (*Nuphar lutea*) (both submerged and emergent forms), with common duckweed (*Lemna minor*) and ivy-leaved duckweed (*Lemna trisulca*) being frequent. Also frequent was Canadian pondweed (*Elodea canadensis*), Nuttall's pondweed (*Elodea nuttallii*), whorled-water milfoil (*Myriophyllum verticillatum*) and stonewort species *Chara* sp. Amphibious bistort (*Persicaria amphibia*) was occasional on bank and in margins. The rare and protected opposite-leaved pondweed (*Groenlandia densa*) is known from this area of the Royal Canal (BEC, 2011; NPWS data) but no stands were observed during the survey (October 2020). It is considered likely that the species is still present but given it is a dark green, submerged pondweed that often sprawls along the bottom, its detection can be difficult.

Overall, site RC1 offered excellent coarse fish habitat for a range of common species including roach (*Rutilus rutilus*), bream (*Abramis brama*), perch (*Perca fluviatilis*) and pike (*Esox lucius*). Well-vegetated canal sections such as this provide valuable nursery habitat for numerous fish species, in addition to good spawning substrata in the spring/early summer months. European eel are known from this section of canal and habitat was considered good. No white-clawed crayfish are known from the eastern extent of the Royal Canal in Dublin City (NBDC, NPWS data, pers. obs.), despite some good physical habitat and physiochemical suitability. No otter signs were recorded during the site visit although suitable marking areas were largely absent.

**Plate 3.4** Representative image of site RC1 on the Royal Canal at Phibsborough (5<sup>th</sup> lock)

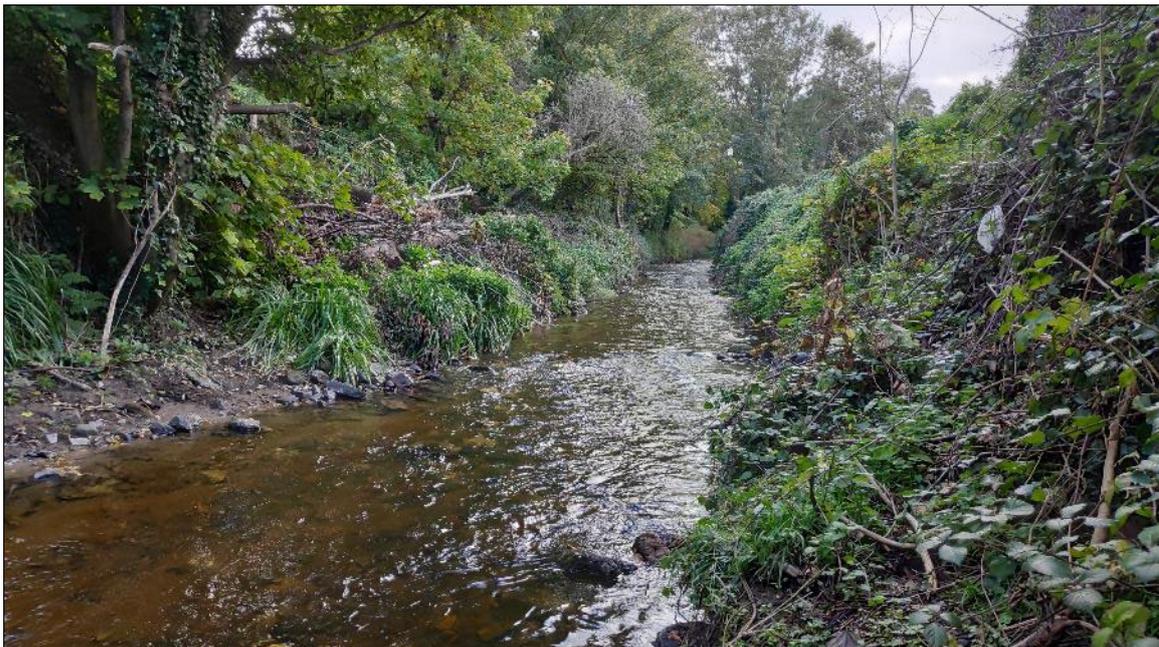
The Owendoher River at site O1 was located approx. 100m upstream of the R114 road bridge (site O2). The upland eroding watercourse (FW1) was swift flowing and averaged 6-7m wide and 0.2-0.5m deep, with localised deeper pool and glide areas to 1m. The river flowed through a semi-natural V-shaped incised valley with bankfull heights of 7-8m (steep sided). The site was characterised by shallow glide (30%) and riffle (60%) with occasional pool areas, usually associated with large instream boulders. The substrata were dominated by partially bedded cobble (40%) with clean sand and fine to medium gravels atop (40% overall). Large boulder was frequent (20%). Siltation was very low with any accumulations of finer substrata dominated by sand. Erosion from floods and human access was evident along both banks. Although adjoined by urban areas (BL3, GA2 etc.), the river was isolated from human activity with poor access via steep

Overall, site O1 offered excellent salmonid habitat, with particularly good spawning opportunities given abundant clean substrata. Whilst limited in extent (site was typically shallow riffle), some very good holding habitat was present in localised small pools (with brown trout evidently plentiful). The site was also a good salmonid nursery. Whilst the site offered some good physical suitability for lamprey spawning, the swift flows and general eroding/spate nature precluded fine sediment deposition and larval habitat was largely absent. European eel habitat was moderate. White-clawed crayfish are not known in the Owendoher, despite some good physical suitability. Otter suitability was very high given low disturbance and good prey resources (but no signs were recorded at this site).

**Plate 3.5** Representative image of site O1 on the Owendoher River (facing upstream)

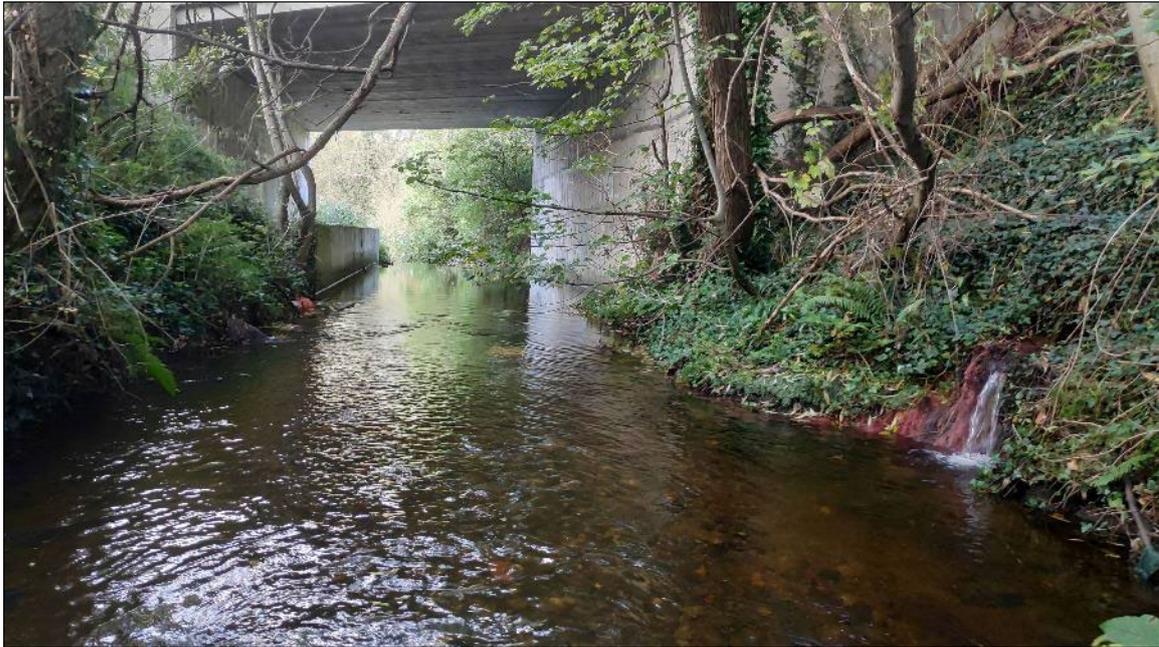
The Owendoher at site O2 was located at the R114 road bridge/culvert, approx. 100m downstream from site O1. Here, the river averaged 6-7m wide and 0.3-0.6m deep, with localised deeper pool and glide areas to 1.2m. The river flowed through a semi-natural V-shaped valley with bankfull heights of 7-8m (steep sided) and was bound by masonry retaining walls under the bridge. In contrast to site O1 upstream, the site was characterised by slower, deeper glide and pool. Downstream of the weir, riffle predominated. The substrata were dominated by partially bedded cobble (30%) with clean sand (30%) and well-sorted gravels (20% overall). There were extensive beds of coarse sand locally. Large boulder was frequent (20%). Siltation was low with any accumulations of finer substrata dominated by sand. Erosion from floods and human interference was evident along both banks. As per site O1, the river was isolated from human activity with poor access via steep banks. The banks supported mature treelines dominated by sycamore, crack willow, ash and elder (*Alnus glutinosa*), with occasional cherry laurel. Buddleja was present downstream of the bridge. The scrubby escarpments supported bramble and ivy with angelica and hedge bindweed. Japanese knotweed and winter heliotrope was scattered throughout the site (but more prevalent upstream). Riparian shading was relatively high and macrophytes were absent. The aquatic moss layer was poorly developed with only localised *Platyhypnidium riparoides* present, with *Hygroamblystegium tenax* on the weir face. The bridge retaining walls did not support vegetation.

**Plate 3.6** Representative image of site O2 on the Owendoher River (facing downstream towards road bridge with point source evident in right foreground)

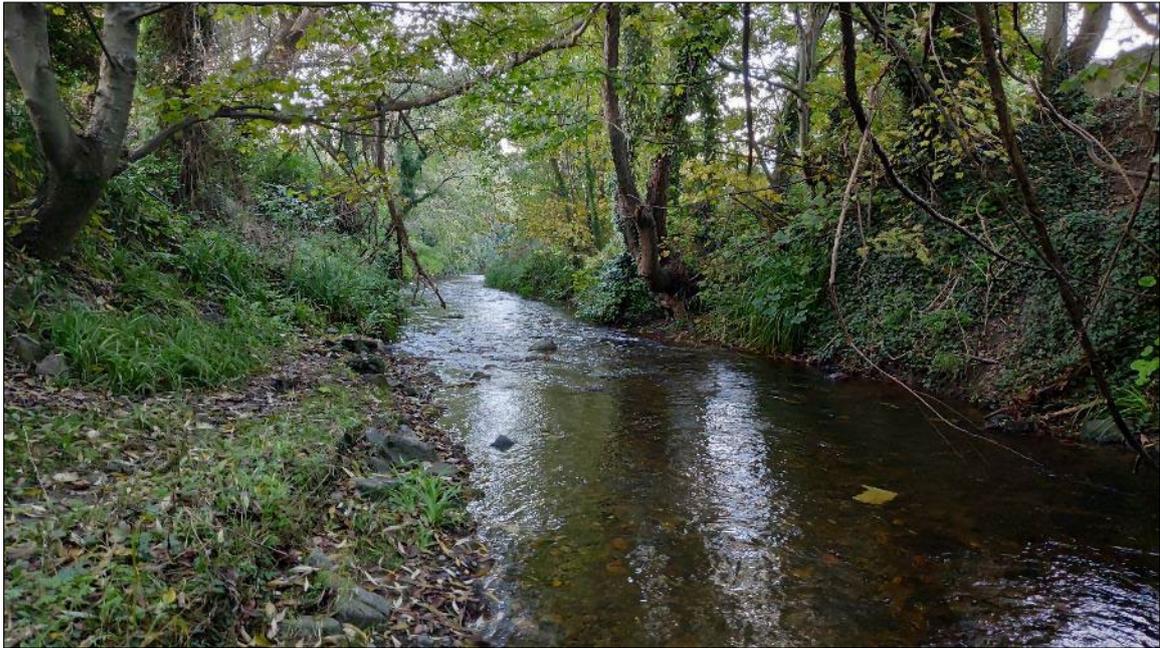
In summary, site O3 showed excellent salmonid habitat with good habitat in particular. Additionally, habitat with high otter potential (including a possible breeding area) was also noted.

**Plate 3.7** Representative image of site O3 on the Owendoher River (facing downstream)

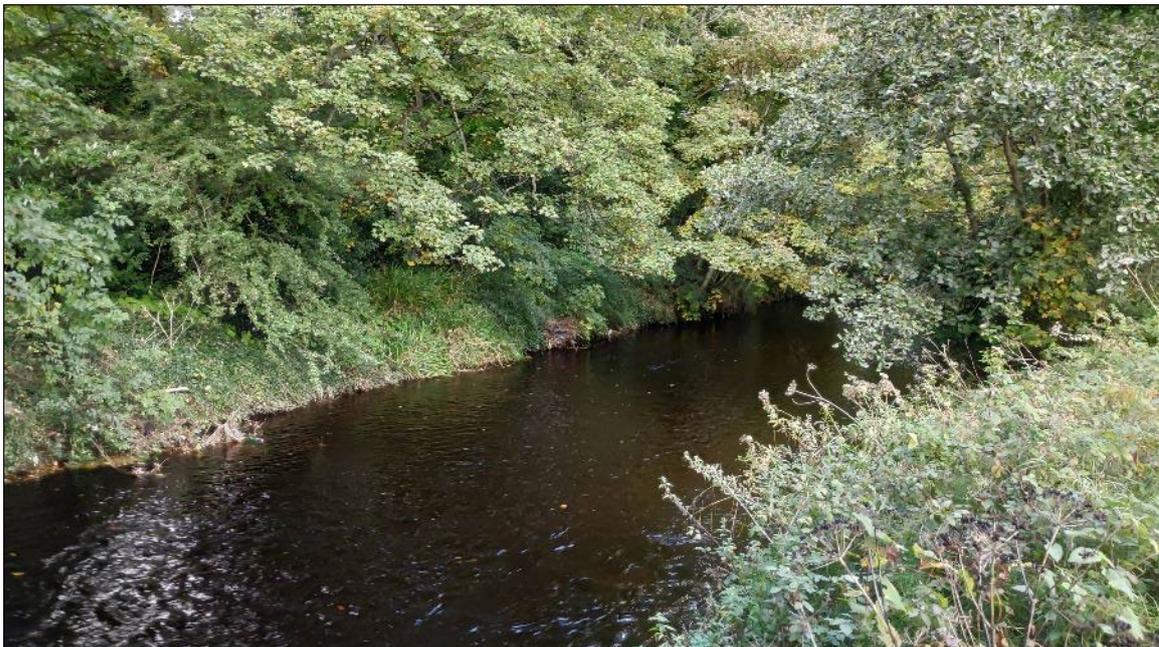
In summary, given the excellent salmonid habitat - in particular spawning gravel, with other areas of good quality nursery and holding habitat observed at this site. Otter activity was not seen at this site during survey, but it is thought that habitat potential at this site was high for this species.

**Plate 3.8** Representative image of site D1 on the River Dodder at Rathdown Park

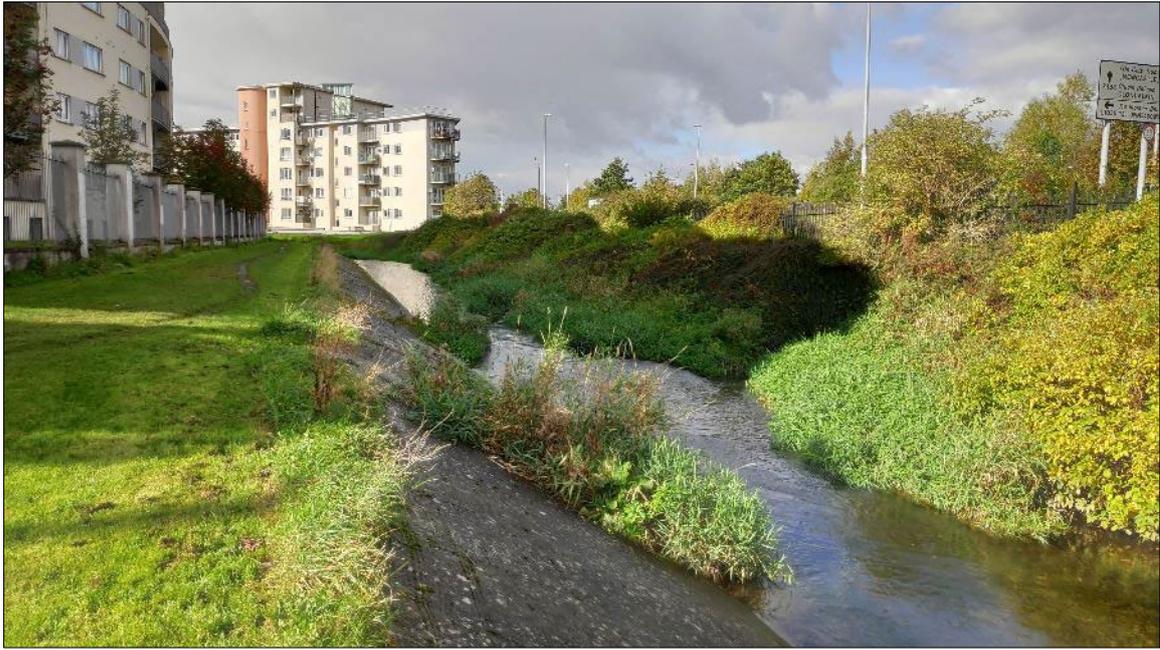
In summary, salmonid habitat was found to be of moderate quality, with moderate quality lamprey habitat and low densities of Annex II white-clawed crayfish at this site.

**Plate 3.9** Representative image of site C1 on the River Camac (facing upstream)

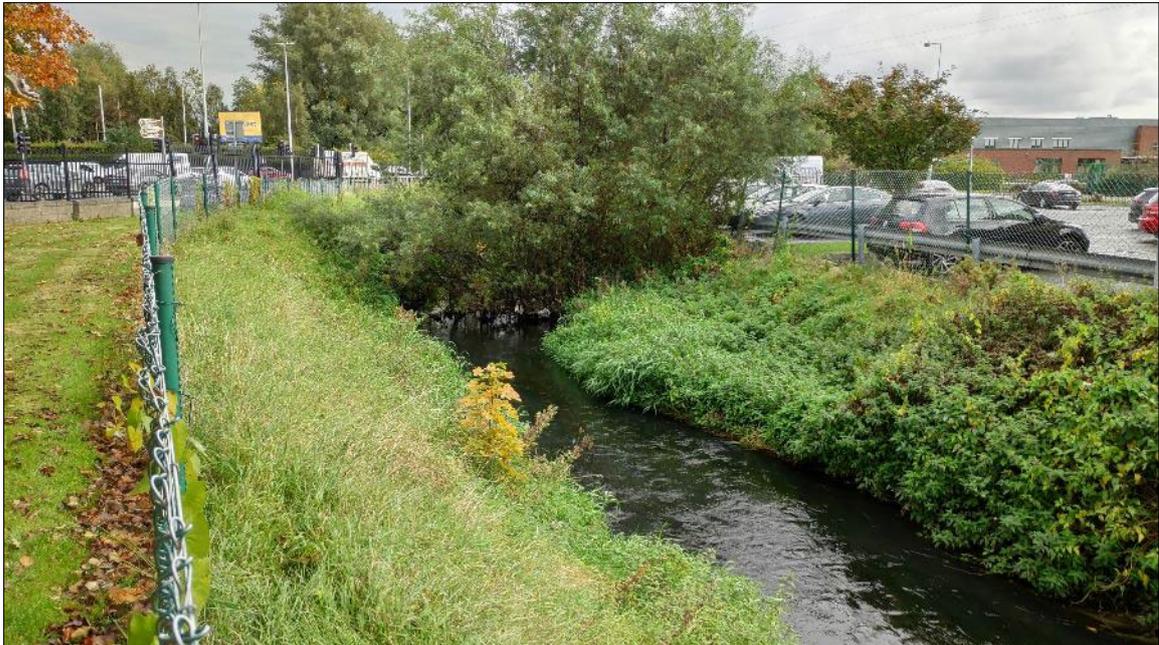
Site C2 offered some very good salmonid habitat (brown trout only). Upstream of the culvert provided excellent quality spawning and nursery habitat (among the best on the entire river) with very good holding habitat for abundant adult trout in undercut banks/under overhanging reed canary grass. A single mature crack willow immediately upstream of the culvert also provided an excellent deep holding pool for adult salmonids. Downstream, whilst spawning and nursery value was somewhat reduced, adult holding habitat was very good given undercut banks and prominent submerged tree roots (willow and sycamore). These also offered excellent refugia for white-clawed crayfish, which were recorded at 'moderate' densities ( $\geq 1$  to  $< 3$  per 10 refugia; Peay, 2003). A total of  $n=8$  crayfish were recorded via sweep netting, with males, females and juveniles present, ranging from 19-41mm carapace length. Lamprey ammocoete habitat was present both upstream and downstream of the culvert, usually in association with instream macrophyte beds. European eel habitat was good throughout but better upstream. Despite known utilisation of the river and abundant prey resource, no otter signs were recorded during the site visit (few suitable marking sites present).

**Plate 3.10** Representative image of site C2 on the River Camac (upstream of the culvert)

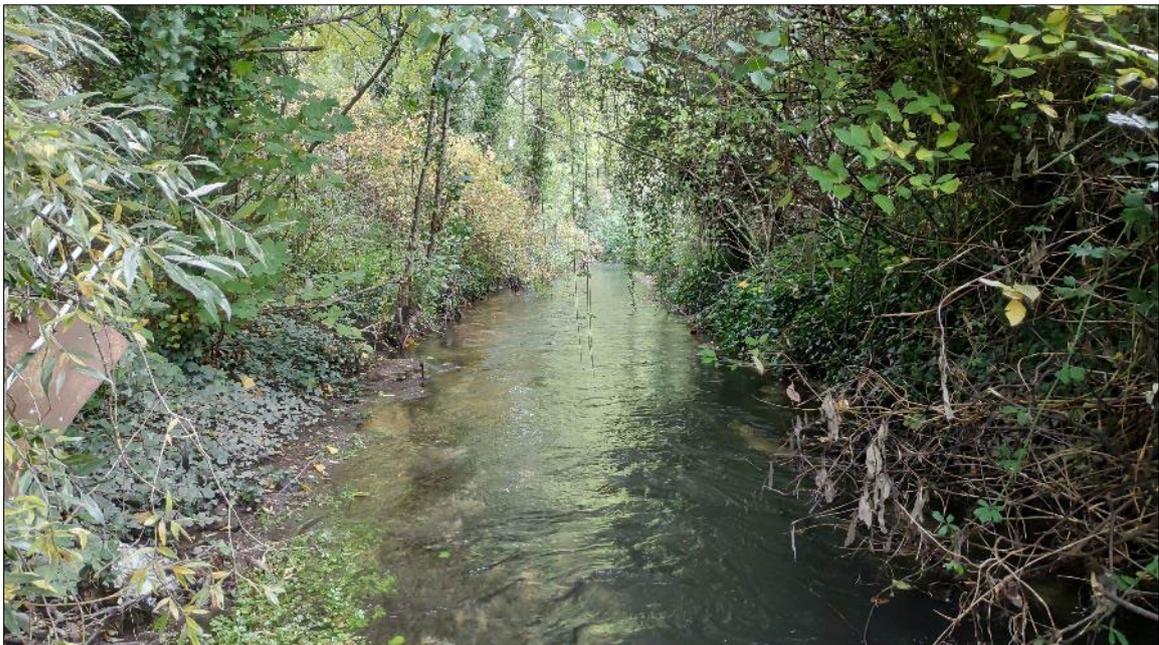
**Plate 3.11** Representative image of site C2 on the River Camac (downstream of the culvert)

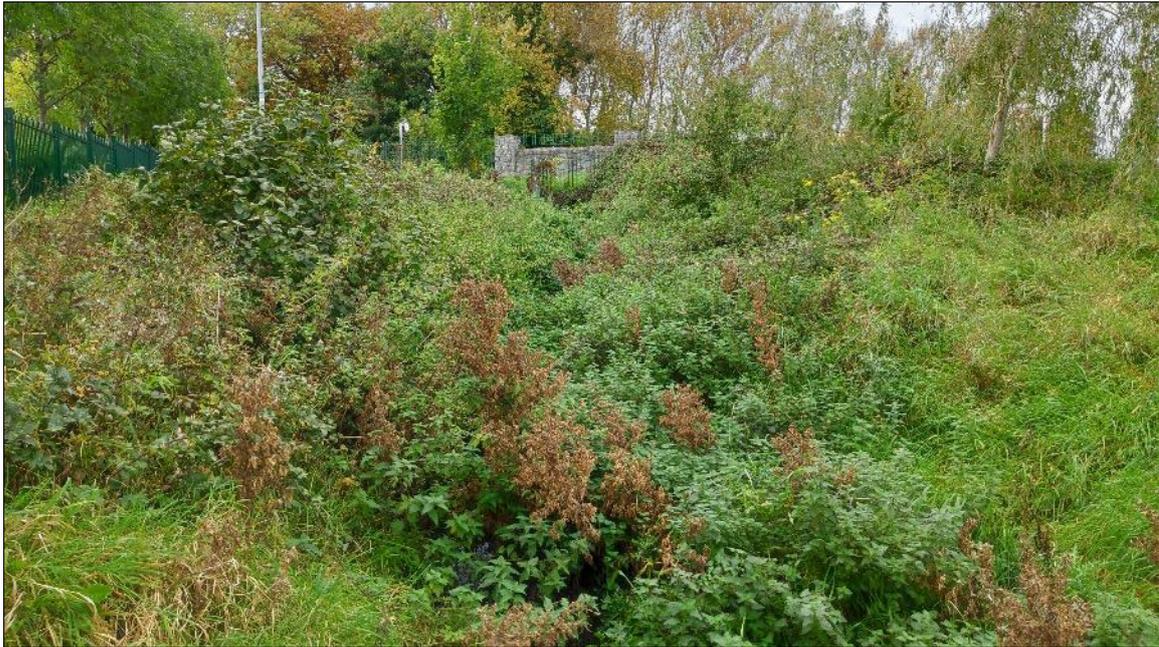
Site P1 was found to have low fisheries value and poor water quality, and of low overall aquatic ecological value.

**Plate 3.12** Representative image of site P1 on the upper reaches of the River Poddle (heavily scrubbed-over, facing upstream to road crossing)
