Stage 1 Road Safety Audit

BusConnects Core Bus Corridors
- Blanchardstown to City Quays

Document Ref: P20-138-PSW1-RP-001

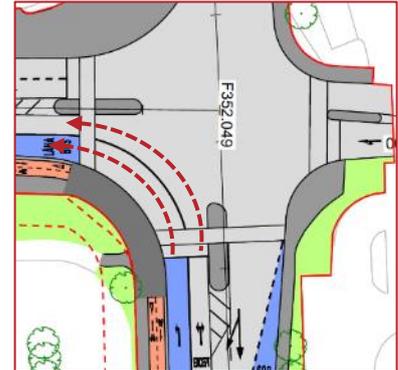
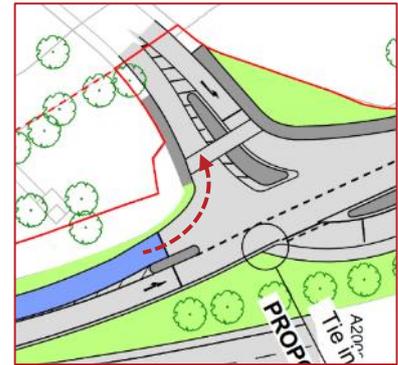
Information regarding the swept path of vehicles undertaking turning movements at proposed signalised junctions within the Scheme have not been provided to the Audit Team. The Audit Team are concerned that there will not be sufficient space at all junctions to accommodate the swept path of all vehicles, particularly HGVs and buses, within the proposed junction layouts. This is a particular concern where adjacent turning lanes proceed simultaneously on one phase as drivers may encroach within the path of an adjacent vehicles resulting in low-speed collisions.

Additionally, during the site visit, the Audit Team noted buses and large vehicles encroaching into adjacent traffic lanes at existing junctions when entering/exiting side roads, for example at the entrance to Connolly Hospital where a bus was observed straddling two lanes of traffic when entering Connolly Hospital. At this particular location it is proposed to provide physical islands which may lead to further difficulties for turning buses.

A comprehensive swept path analysis should be undertaken to demonstrate that all new, and revised, signalised junctions can sufficiently accommodate the swept path of all vehicles. Where constraints are identified, the layout should be revised to ensure all vehicle movements can be accommodated.

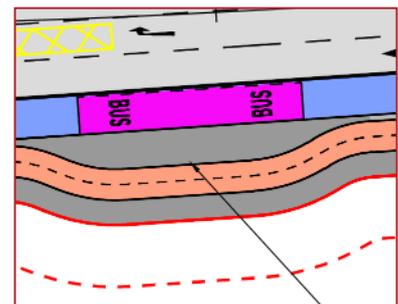
Summary: It is unclear if there will be sufficient space at bus stops within the Scheme to accommodate bus shelters as these have not been indicated at any locations on the drawings provided.

The Legend on the drawings provided contains a symbol for bus shelters however none of the bus stops along the Scheme indicate a bus shelter. While a bus shelter may not be provided at all bus stops within the Scheme it is likely that a number of bus shelters, particularly those indicated on widened sections of footpath and within shared surfaces, will contain bus shelters. Assuming that bus shelters will be provided at some locations, it is unclear if there will be sufficient effective residual footpath width for pedestrians, in particular mobility impaired pedestrians, at these bus stops to continue safely and independently along the footpath.

Where bus shelters are provided ensure a minimum effective residual footpath width of 1.2m is provided.

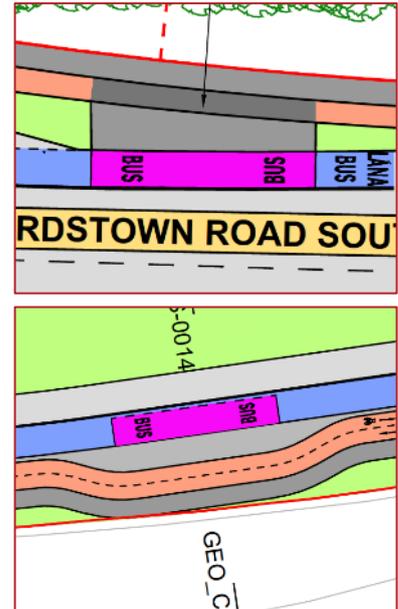
An absence of Guidance Tactile Paving could result in increased difficulties for the visually impaired who may be unaware of how to access or leave the bus stop island.

Where no connection has been indicated between the footpath and the bus stop island, this will result in mobility impaired & visually impaired road users being unable to access the public transport provisions, and there would be an increased potential for cyclist/pedestrian collisions as embarking/disembarking passengers traverse the cycle track.

A link should be provided between the proposed island/floating bus stops and the adjacent footpath, with the cycle track crossing the footpath link. Guidance Tactile Paving should be provided to guide visually impaired pedestrians to/from the footpath & the bus stop island.

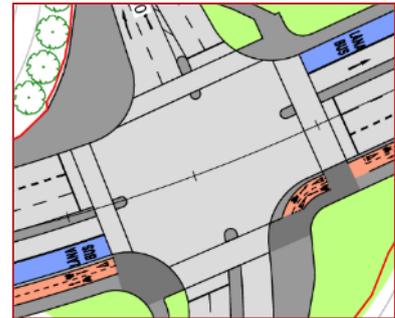
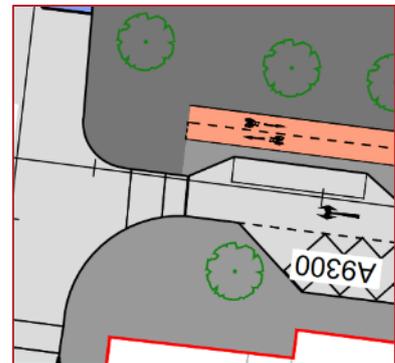
It is unclear if these crossings will be toucan crossings. If these crossings are not toucan crossings there is a risk that the crossing will not be sufficiently wide enough to safely accommodate pedestrians and cyclists and will not provide measures (separate push button/signal head) for cyclists. This could lead to an increased risk of conflicts between pedestrian and cyclists when accessing, waiting at and using the crossing.

This problem is exacerbated at locations where narrow footpaths continue downstream of the shared surfaces (e.g. northern side of Bus Interchange Western Access in Blanchardstown Shopping Centre and north of Blackhall Place/Blackhall Street junction) which may not be sufficiently wide enough to accommodate both cyclists and pedestrians.

Ensure all crossings at shared surfaces throughout the Scheme are toucan crossings.

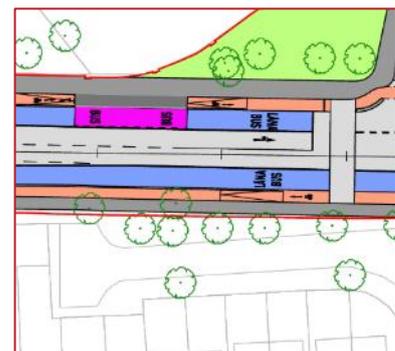
Summary: Buses stopped at bus stops upstream of signalised junctions may block a driver's visibility to the signals.

At a number of locations within the Scheme, bus stops have been indicated upstream of signalised junctions and signalised pedestrian crossings. A stationary bus at the bus stop may block visibility for a driver in the adjacent traffic lane to the nearside primary signal head on approach to the junction/crossing. This could lead to drivers being insufficiently aware of a red signal at the junction/crossing leading to them failing to moderate their speed and/or stop at the junction resulting in overshooting the stop line and possible collisions with pedestrians using the crossing or opposing vehicles within the junction.

If possible, bus stops should be located downstream of signalised junctions and pedestrian crossings.

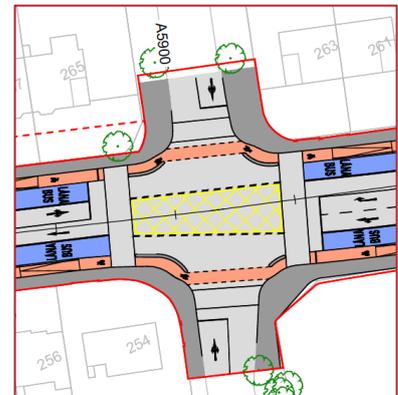
Protected intersections have been indicated at a number of junctions within the Scheme including the Old Cabra Road/North Circular Road junction and on the Navan Road at its junctions with Kinvara Avenue, Nephin Road and Skreen Road. It is unclear how it is intended that cyclists should turn right at these junctions as no measures appear to be provided to facilitate this manoeuvre.

This could lead to cyclists entering/crossing traffic lanes where there is an increased risk of being struck by a vehicle. Alternatively, cyclists may attempt to use the pedestrian crossings which, if these are not toucan crossings, may not safely accommodate both cyclists and pedestrians.

Cyclist 'box turns' should be provided ahead of the stop line, but outside the through cycle lane at these junctions. This will allow right turning cyclists to exit the through cycle lane and wait in this right turn box for a green phase on the side road where they can then proceed straight ahead with through traffic. These may require the position of the pedestrian crossings and stop lines on the side roads to be amended.

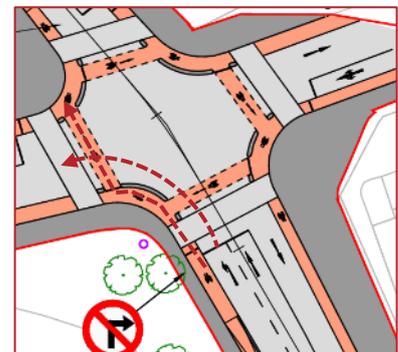
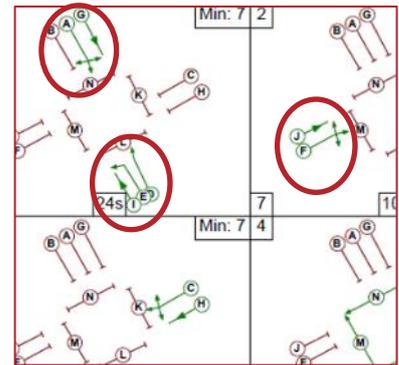
Summary: Left turning manoeuvres are indicated during the same signal phase as straight-ahead cyclists where turning drivers may be insufficiently aware of cyclist proceeding straight at a number of the protected intersections/junctions within the Scheme.

At a number of signalised protected junctions within the Scheme left turning manoeuvres are indicated as occurring during the same phase as straight-ahead cyclists. In some instances the, straight through cycle lane is offset from the adjacent traffic lane, and is positioned closer to the pedestrian crossing on the intersected road.

There is a risk that drivers, when given a green signal, may not anticipate a straight through cyclist, possibly misinterpreting the layout as a signalised/toucan crossing on a separate phase, resulting in possible vehicular/cyclist collisions.

In addition, there is a concern that some cyclists may choose to take a more direct route along their desire line, and enter the carriageway at the pedestrian crossing gap where they are at an increased risk of being struck by vehicle.

Reduce the lateral displacement of the straight through cycle lane from the adjacent traffic lane(s) to improve driver’s awareness of possible straight through cyclists. Amend the left turn signals so that left turns are on a flashing amber.

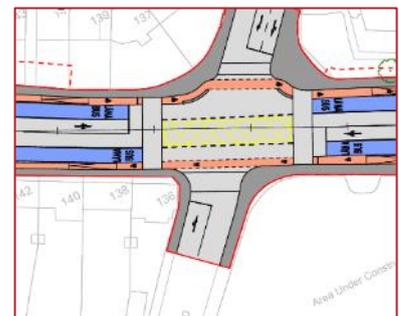
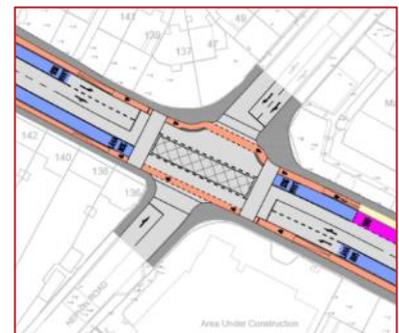
Summary: The layout of the bus lane at the stop line at signalised junctions on the drawings provided differs to the layouts which accompany the signal phase diagrams.

There is an inconsistency in the layout of the proposed bus lane where it terminates at the stop line at a number of signalised junctions within the Scheme between the drawings provided and the images which accompany the signal phasing diagrams. On the drawings provided the bus lane is indicated as extending as far as the stop line while on the images accompanying the signal phase diagrams the bus lane is curtailed upstream of the junction and a left turn lane provided for left-turning vehicles at the junction.

The phasing diagrams indicate that straight ahead and left turn manoeuvres are permitted simultaneously. In the layout indicated on the drawings provided this would result in left-turning private vehicles turning across the path of straight-ahead buses resulting in an increased risk of side-on collisions.

Ensure the proposed design drawings and the proposed signal phasing diagrams reflect the same junction layout. Permitted vehicle movements which reduce the number of potential conflict points at signalised junctions are preferable.

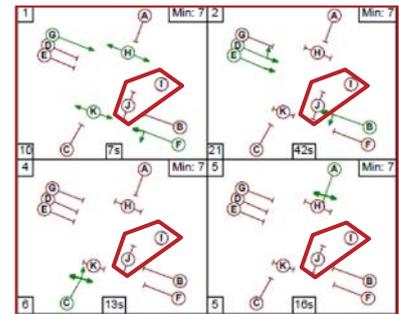
At a number of signalised junctions throughout the Scheme including, but not limited to, those listed above, the pedestrian and cyclist crossings have not been indicated within the proposed signal phasing diagrams, and in some cases have been included but do not get a green signal in any phase.

A failure to provide phases for vulnerable road users within signalised junctions may lead to pedestrians and cyclists becoming impatient and frustrated resulting in the potential for them to cross the carriageway during a red signal where there is an increased risk of being struck by a vehicle whose driver would not be anticipating a VRU to cross ahead of them.

Ensure phases are provided for all pedestrian and cyclist movements at signalised junctions and that these occur independently of opposing vehicular movements.

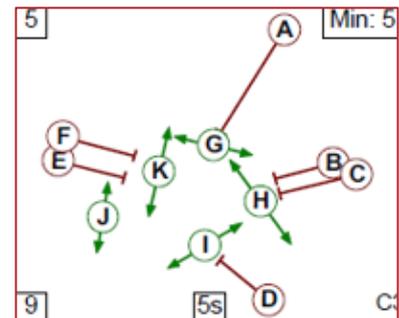
At a number of signalised junctions within the Scheme, pedestrian phases have been indicated as between 5, and 7, seconds long. The Audit Team are concerned that this will not be sufficient time for some non-motorised road-users (e.g. elderly & mobility impaired) to complete a crossing in one phase particularly where two-stage crossings are provided during the same phase.

This could lead to mobility impaired pedestrians remaining within the carriageway when a subsequent green vehicular phase has been triggered increasing the risk of vehicle-pedestrian collisions resulting in serious injuries or fatalities.

Ensure pedestrian green phases are of a sufficient length such that all non-motorised road users can complete the crossing safely.

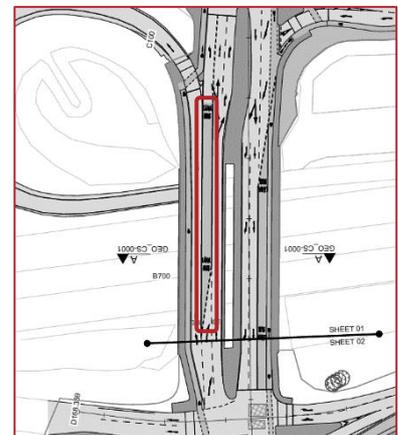
A short length of northbound bus lane (less than 100m) has been indicated on the N3 overbridge between the two signalised junctions on either side of the bridge on Blanchardstown Road. The bus lane requires northbound traffic to merge over a short distance downstream of the western junction before diverging again upstream of the eastern junction where the bus lane is curtailed at the left turn lane.

This could lead to an increase in the volume of merging/diverging traffic at this location resulting in an increased risk of side swipe collisions.

The northbound bus lane on the bridge should be removed and recommenced on Blanchardstown Road North downstream of the junction.

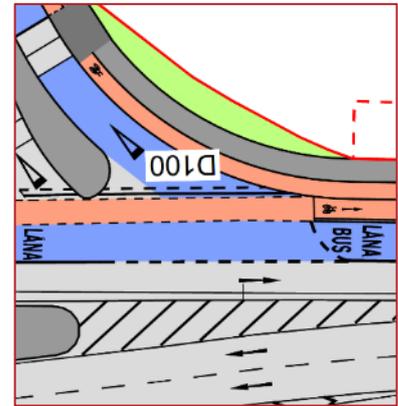
Summary: The left turn bus lane from the N3 junction 3 northbound off-slip onto Blanchardstown Road South directs buses into the kerbline where the cycle track transitions from the carriageway to the off-road facility.

The westbound cycle track transitions from the carriageway of the Blanchardstown Road South to off-road cycle facilities immediately downstream of the exit for buses from the N3 junction 3 northbound off-slip. A kerb is indicated as developing at this location where the cycle track rises from the carriageway. The kerb is located such that left turning buses from the adjacent off-slip may strike the kerb when entering the westbound bus lane resulting in material damage.

Ensure that the kerb line between the slip road and Blanchardstown Road South directs turning buses into the bus lane, and not onto the cycle lane. In addition, undertake a swept path analysis to ensure that buses can undertake a turning manoeuvre without mounting the downstream kerb at the commencement of the raised/protected cycle lane.

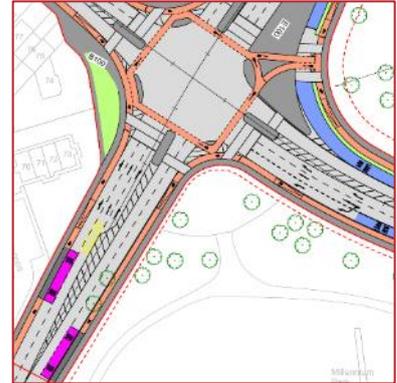
Summary: Southbound drivers may be insufficiently aware of the reduction from two lanes to one lane on Blanchardstown Road South downstream of the proposed bus stop.

It is proposed to amend the existing roundabout junction of Blanchardstown Road South and Blakestown Way to a signalised junction. Two southbound through lanes have been indicated on Blanchardstown Road South at the proposed signalised junction which are maintained on the southern side of the junction. To the south of the existing roundabout there is only a single through traffic lane and a bus lane on the nearside. The proposed Scheme terminates at a bus stop to the south of the junction where two lanes continue. It is unclear if the nearside lane will tie-into the existing bus lane further downstream. If this is the case, there is a risk that drivers will be insufficiently aware of the lane drop south of the junction resulting in an increased risk of side swipe collisions as drivers suddenly merge into the adjacent lane.

Drivers should be advised of the need to merge immediately downstream of the junction (i.e. swerve arrows).

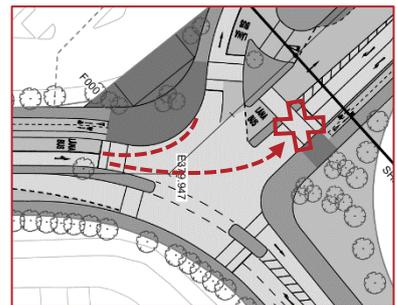
Summary: Straight ahead and left turn movements occur at the same time as the adjacent bus lane at the Bus Interchange Western Access signalised junction in the Blanchardstown Shopping Centre.

The straight ahead and left turn eastbound movements at the Bus Interchange Western Access signalised junction in the Blanchardstown Shopping Centre are indicated as occurring on the same phase as the adjacent bus lane. Priority has not been clearly indicated for buses within the signals at this location and this will lead to left turning drivers turning across the path of straight-ahead buses resulting in side-on collisions.

Additionally, left turning drivers may mistake the northbound bus lane or southbound traffic lane for their lane as this is located within the natural turning arc of a left turning vehicle. Should a left-turning driver mistake the southbound lane for their downstream lane there is an increased risk of head-on collisions.

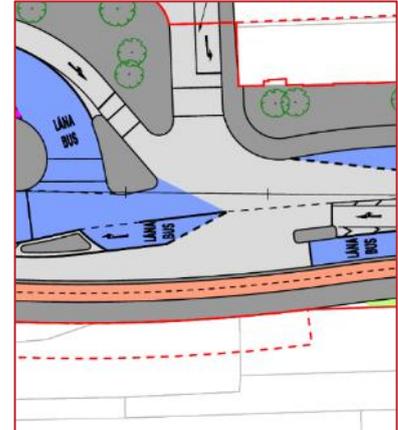
Summary: Unclear if the proposed right turn lane for buses entering the bus interchange at its eastern entrance will be of a sufficient size to accommodate buses without encroaching into the westbound traffic lane.

A short section of bus lane has been indicated on the eastern side of the proposed bus interchange in the Blanchardstown Shopping Centre to allow a right turning bus to wait outside of the through traffic lane. It is unclear if there is sufficient space within this lane for a bus to wait for a green signal without encroaching into the through traffic lane. If the right turn bus lane does not provide sufficient space to accommodate a stationary bus within its extents, there is a risk that the overhang of a bus may block the westbound traffic lane resulting in the potential for collisions between westbound vehicles and a stationary right-turning bus.

Ensure there is sufficient space for a right turning bus to wait within the right turn lane without encroaching into the adjacent traffic lane.

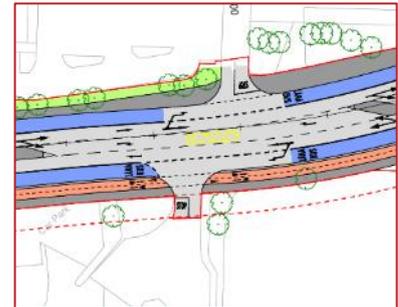
Summary: Opposing right turning lanes with no physical delineation may result in head-on conflicts.

A number of carpark accesses are located on the access road within the Blanchardstown Shopping centre between the proposed signalised junction at the Crowne Plaza Hotel and the proposed signalised junction at the L3020/Westend Office Park. It is proposed to provide a series of right turn lanes to these car park entrance resulting in a number of opposing right turn lanes being created.

All of the opposing right turn lanes on this road are physically separated by splitter islands with the exception of the opposing right turn lanes closest to the L3020/Westend Office Park junction which is delineated by yellow box roadmarkings only. These measures may not be sufficient to warn drivers of the opposing right turn lane, particularly as the roadmarkings may fade overtime, leading to a risk of drivers overshooting the end of their lane resulting in head-on collisions with oncoming right turning vehicles.

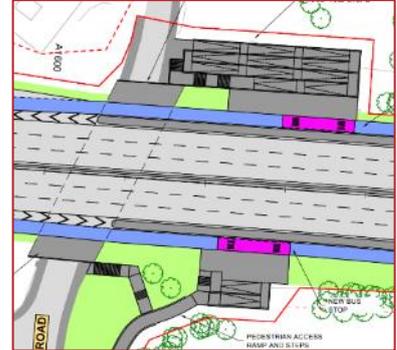
It is proposed to provide two bus stops within the dual carriageway section of the N3. Access to these bus stops for pedestrians is proposed via steps and ramps from Mill Road which runs in a north to south direction beneath the N3 carriageway.

Information regarding the gradients of the ramps have not been included on the drawings provided and it is therefore unclear if the gradients associated with the ramps will be sufficient for pedestrians, particularly mobility impaired pedestrians. Steep gradients may make it difficult for pedestrians, particularly mobility impaired pedestrians and the elderly, to safely and comfortably navigate the pedestrian ramps, leading to slips, trips and falls.

While landings have been indicated between the rises it is unclear if these are of a sufficient size for a wheelchair user to stop and turn safely.

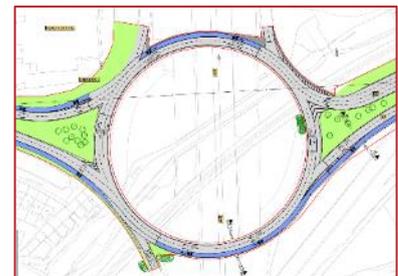
Summary: It is unclear if the lanes at the eastbound and westbound entries to the rotary will sufficiently accommodate the swept path of adjacent vehicles due to the horizontal bend on the approaches.

A bus gate has been indicated on the nearside on the eastbound and westbound approaches to the rotary at the interchange between the M50 and the N3 with a splitter island between the bus lane and the adjacent traffic lanes. Horizontal curves are located upstream of the entries to the rotary on both of these approaches. It is unclear if the horizontal alignment and splitter island can accommodate the swept path of large vehicles entering the rotary.

Should there be insufficient space within the traffic lanes at the eastbound and westbound entries to the rotary there is a risk of vehicles encroaching into the adjacent lane and side swipe collisions or kerb strikes at the splitter island between the traffic lane and bus lane.

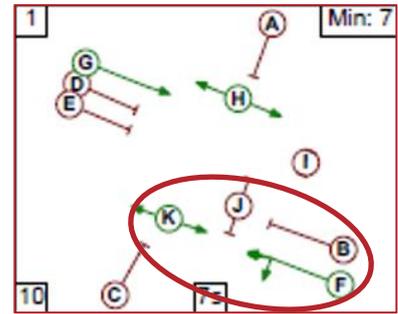
Summary: Risk of pedestrians crossing Auburn Avenue being struck by left-turning vehicles.

In Phase 1 of the proposed traffic signal cycle at the junction of the Navan Road and Auburn Avenue the westbound straight ahead and left turn lane on Navan Road is indicated as being given a green signal at the same time as the pedestrian crossing of Auburn Avenue. This will lead to an increased risk of pedestrians crossing Auburn Avenue being struck by left-turning vehicles.

The pedestrian crossing of Auburn Avenue should occur on a separate phase to left-turning vehicles from Navan Road.

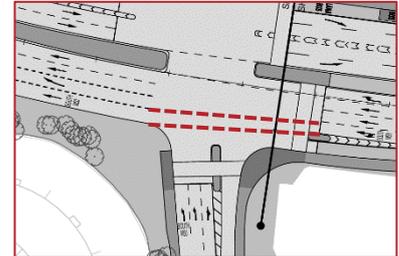
Summary: Guidance markings may be required to guide westbound drivers into the M50 Southbound lane downstream of the N3/Auburn Avenue junction.

The straight-ahead lane for the M50 southbound does not align with the upstream lane on the western side of the junction. This may lead to westbound drivers being insufficiently aware of the need to move left when travelling through the junction resulting in poor lane discipline and the potential for drivers to encroach into the path of vehicles in the adjacent lane resulting in potential side swipe collisions.

Guidance markings should be provided through the junction linking the M50 southbound lanes upstream and downstream of the junction.

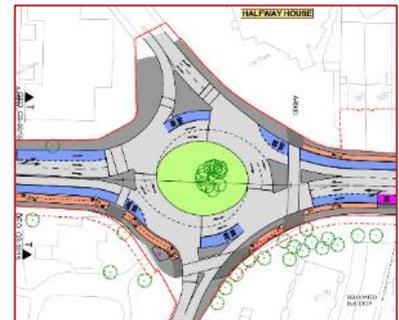
Summary: The roundabout at the intersection of the Navan Road, Castleknock Road and Ashtown Road may not be of a sufficient size to operate safely as a signalised roundabout.

It is proposed to signalise the existing roundabout junction of the Navan Road, Castleknock Road and Ashtown Road located adjacent the Halfway House bar/restaurant. The proposed signalised arrangement includes three lanes on the Navan Road approaches, a bus lane and left turn lane, a straight-ahead lane and a right turn while the Ashtown Road approach includes two lanes and the Castleknock Road approach a single lane. Three lanes are proposed on the roundabout circulating carriageway with spiral markings indicated guiding drivers into the appropriate lanes as they traverse the roundabout. Signalised pedestrian crossings are indicated on all arms and four stop lines are indicated on the circulating carriageway.

The proposed layout could result in a number of safety issues, as follows: -

1. The distance between the stop lines on the roundabout circulating carriageway is short such that there is a risk of queues extending to the upstream stop line, pedestrian crossings and entries to the roundabout blocking access to traffic and potentially leading to congestion.

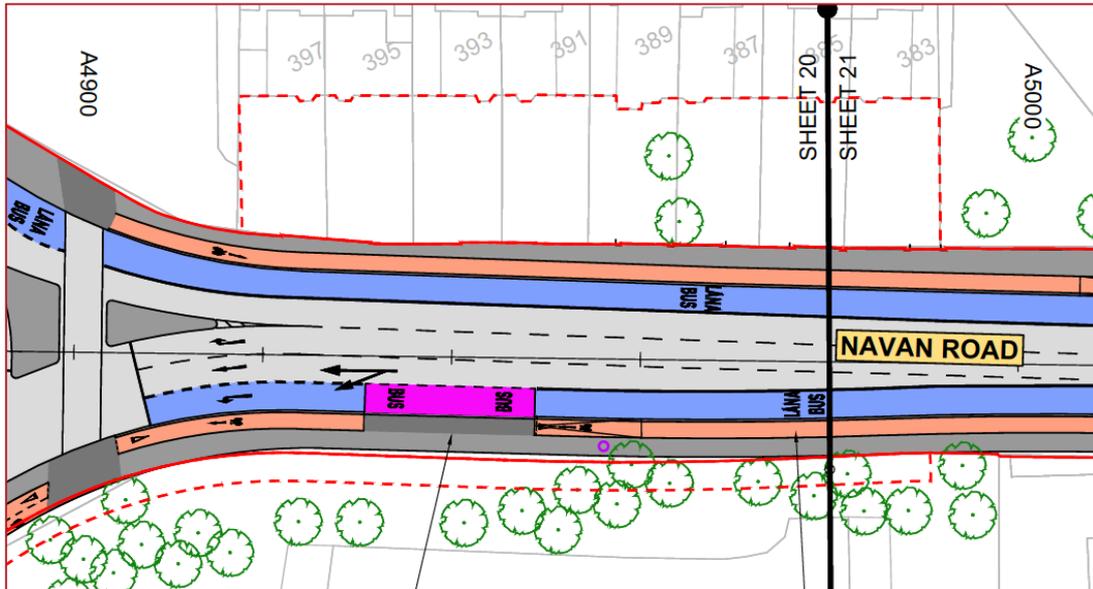
Location: Drawing no. BCIDC-ARP-GEO_GA-0005_XX_00-DR-CR-0020/21 (Rev. L01)

Summary: The westbound straight-ahead lane continues into the right turn lane at the roundabout at the Halfway House bar/restaurant.

The westbound straight-ahead lane on the Navan Road continues to form the right turn lane upstream of the proposed signalised roundabout junction at the Halfway House bar/restaurant. Westbound drivers may be insufficiently aware of the lane becoming a right-turn-only lane on the approach as only a single right turn arrow is indicated immediately upstream of the stop lane. This could lead to westbound drivers becoming aware of the change in road layout immediately upstream of the roundabout resulting in late lane-change manoeuvres and possible side-swipe collisions.

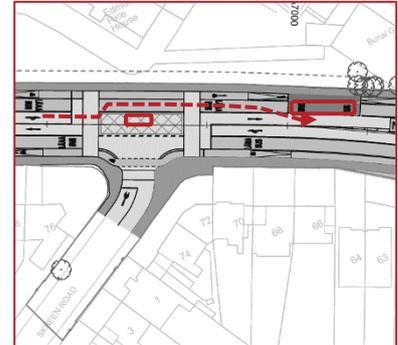
Summary: Through traffic passing right-turning vehicles at junctions may collide with a stationary bus at the bus stop downstream of the junction.

Eastbound bus stops have been indicated on the Navan Road immediately downstream of its junctions with Kinvara Avenue, Nephin Road and Skreen Road. There is a single traffic lane for eastbound drivers at these junctions and right turning, and straight-ahead, vehicles are given a green signal during the same phase.

This may lead to right turning vehicles blocking through traffic as they wait for a gap in westbound traffic. Should the adjacent bus lane be clear, through traffic may pass a stationary right turning vehicle on the nearside to proceed eastbound. However, should an eastbound bus be slowing down, or stopping, at the bus stop downstream, and an undertaking driver be insufficiently aware of this prior to passing the right turning vehicle, there is a risk of rear end shunts with vehicles at the bus stop.

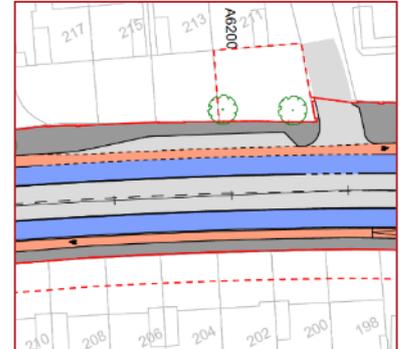
Summary: Unclear if existing set-down area, which is proposed to be retained, at the school adjacent Our Lady Help of Christians Church is sufficiently wide enough to accommodate a bus without it encroaching into the adjacent cycle track.

There is an existing set-down area located on the northern side of the Navan Road at the school adjacent the Our Lady Help of Christians Church which is assumed to be used by school buses during school drop-off and pick-up times. The width of the set-down area is unclear, and the Audit Team area concerned that it may not be sufficiently wide enough to accommodate a bus without the bus encroaching into the adjacent cycle track. Should the bus encroach into the cycle track there is a risk that cyclists may enter the bus lane to avoid a stationary school bus resulting in an increased risk of being struck by a bus.

During the site visit, the Audit Team noted a number of cars using this set down area during school drop-off times. If it is intended for buses only, and is occupied by private cars, there is a risk that school buses may block the adjacent cycle track or bus lane when dropping off or picking up students increasing the risk of cyclists and buses suddenly entering into the eastbound traffic lane and colliding with westbound traffic.

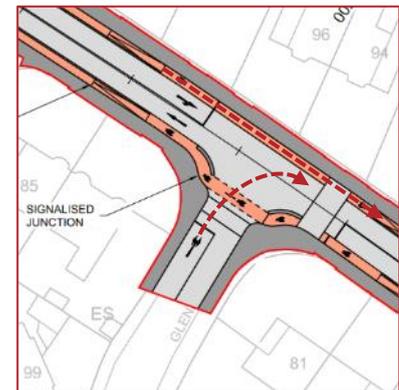
Summary: Risk of right-turning drivers from Glenbeigh Road encroaching into the straight-ahead cycle track on Old Cabra Road resulting in the potential for collisions with southbound straight-ahead cyclists.

Left turns and right turns from Glenbeigh Road at its junction with Old Cabra Road are permitted during the same green signal phase as southbound cyclists on Old Cabra Road. Right-turning drivers exiting Glenbeigh Road may not anticipate southbound cyclists to proceed at the same time and potentially swing wide when turning right and encroach into the cycle track, where it is located at carriageway level, which could lead to an increased risk of side swipe collisions with southbound cyclists.

Either, amend the proposed signal phasing so that the turning manoeuvres out of Glenbeigh Road occur on a separate phase to southbound cyclists to reduce the risk of collisions, or keep the cycle lane vertically separated from the carriageway through the junction, and ramping down only on the immediate approach to the pedestrian crossing.

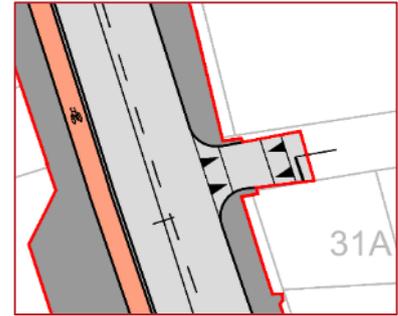
Summary: Proposed raised table at St. Joseph's Place does not align with the adjacent footpath.

A raised table has been indicated on St. Joseph's Place at its junction with Prussia Street. The level top of the raised table however does not align with the footpath either side of St. Joseph's Place. This could lead to trips and falls for pedestrian who, should they follow the line of the building boundary when crossing St. Joseph's Place, will be travelling on ramped surface.

Mobility impaired pedestrians may also be unable to cross St. Joseph's Place as they will be required to descend the kerb where the raised table ramps towards the carriageway. Similarly, visually impaired pedestrians may be insufficiently aware of the location of the crossing of the raised table as it is inset into the side road. This will result in visually, and mobility, impaired pedestrians being unable to safely and independently navigate the road layout.

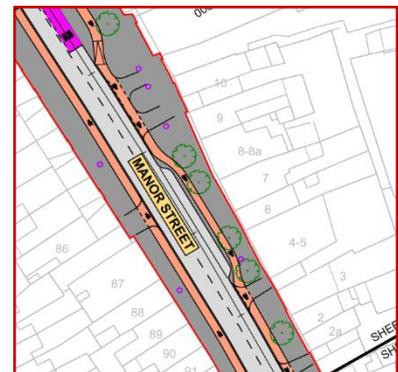
Parallel parking has been indicated immediately upstream of a number of private accesses on Manor Street. Additionally, a bus stop is also indicated immediately upstream of two accesses to the north of the parallel parking bays.

There is a risk that, should a bus be stopped at the bus stop or vehicles parked in the parallel parking bays, drivers turning left into these accesses may have insufficient visibility towards an approaching cyclist on the adjacent cycle track leading to possible vehicle/cyclist collisions.

Ensure sufficient visibility is provided towards the cycle track for drivers turning left into these accesses.

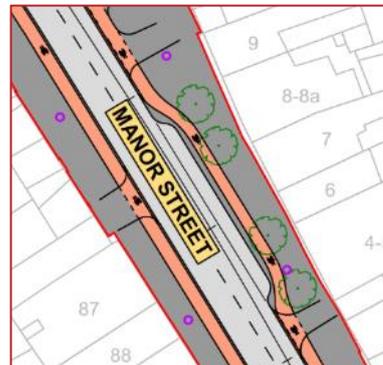
Summary: The width of the parallel parking spaces indicated on Manor Street and Blackhall Place are unclear.

Parallel parking spaces have been indicated on Manor Street and Blackhall Place. The width of these parking spaces is however unclear from the drawing provided and the Audit Team are concerned that they may not be sufficiently wide to accommodate vehicles without them encroaching into the adjacent traffic lane, as they appear narrow relative to the traffic lanes. Should the vehicles encroach into the traffic lane there is a risk that drivers may cross the centreline/edge of traffic lane and enter the opposing traffic lane to avoid a stationary vehicle resulting in an increased risk of head-on, or material damage, collisions.

Ensure the parallel parking spaces are sufficiently wide enough to accommodate a stationary vehicle.

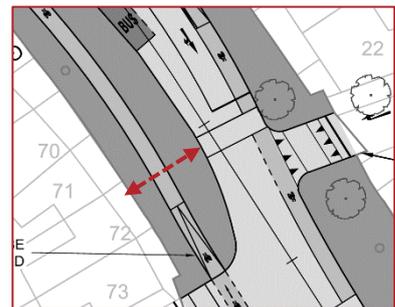
Summary: Pedestrians are required to cross the cycle track to access the pedestrian crossing on the northern arm of the Manor Street/Kirwan Street junction.

The cycle track is indicated as traversing the wide footpath on the western side of Manor Street, immediately north of its junction with Kirwan Street such that pedestrians accessing the crossing from the rear of the footpath on the northern arm of the junction are required to cross the cycle track to do so.

It is unclear who has priority at this location. This could lead to cyclists and pedestrians believing that they have priority and proceeding without due care and attention resulting in an increased risk of pedestrian-cyclist collisions.

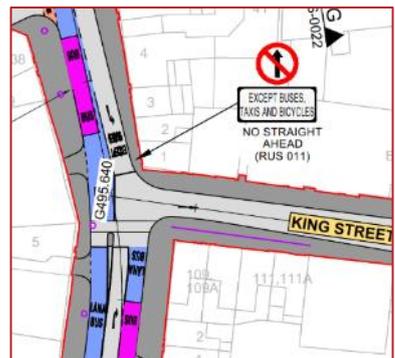
Summary: Pinch point in the footpath at the corner of the North King Street/Stoneybatter junction.

The existing building line on the north-eastern corner of the North King Street/Stoneybatter junction results in a pinch point in the footpath, reducing the effective width of the footpath. It is likely that items of roadside furniture such as traffic signals and signs will also be required at this location which may further reduce the effective width of the footpath. This could lead to pedestrians having to step into the carriageway to avoid oncoming pedestrians where there is an increased risk of being struck by a vehicle.

During the design development ensure that the effective width of the footpath at this location is a minimum of 1.2m, and that items of roadside furniture do not create obstacles for non-motorised road users.

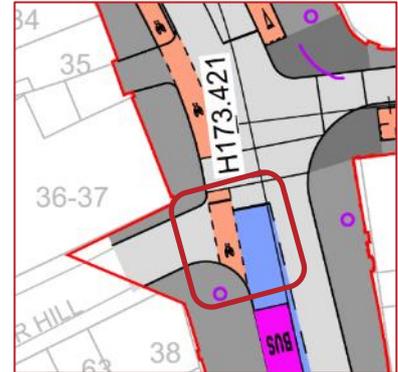
Summary: Northbound buses/cyclists stopped at the stop line on Manor Street at its junction with Brunswick Street may block access/egress to/from Arbour Hill.

The stop line for northbound buses and cyclists on Manor Street at its signalised junction with Brunswick Street is located such that drivers stopped at this location may block access/egress to/from Arbour Hill which is not included within the signalised junction. This could lead to driver frustration, should they experience delays when entering/exiting Arbour Hill, resulting in a risk of unsafe entry/exit manoeuvres to/from Arbour Hill and a resultant increased risk of collisions.

The stop line on Manor Street for northbound buses/cyclists should be relocated further upstream and the existing yellow box junction markings at the junction should be retained.

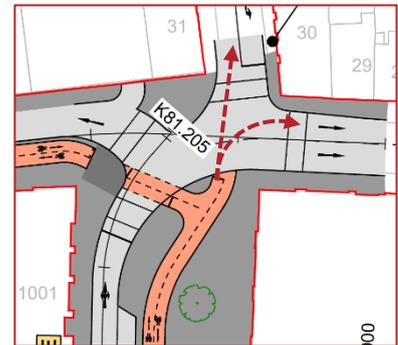
Summary: Unclear how northbound cyclists on the two-way cycle track on George's Lane enter the junction at Brunswick Street as they do not appear to be included in any phases at the junction.

The two-way cycle track, travelling from north to south along George's Lane, is indicated as terminating at the signalised junction of George's Lane/Brunswick Street/Grangegorman Lower. It is assumed that a dropped kerb will be provided at the northern end of the cycle track and that southbound cyclists on Grangegorman Lower wishing to enter the southbound cycle track will do so on the same phase as vehicular traffic exiting Grangegorman Lower. It is unclear however how northbound cyclists will proceed onto the carriageway as this movement does not appear to be included in any of the phases indicated. If they were to proceed with vehicular traffic on George's Lane, there is a risk of conflicts between vehicles turning right into Brunswick Street and northbound cyclists entering the carriageway.

An on-demand phase should be included in the traffic signal cycle allowing northbound cyclists to proceed unopposed into Brunswick Street or Grangegorman Lower. Alternatively, this movement should be incorporated into Phase 1.

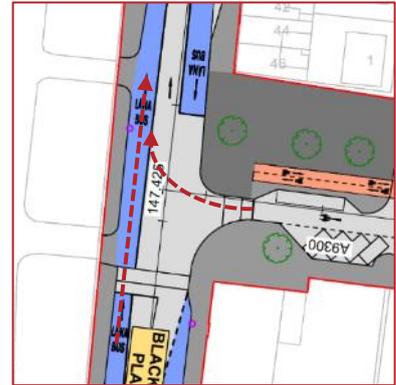
Left turns and right turns from Blackhall Street at its junction with Blackhall Place are permitted during the same green signal phase as northbound buses on Blackhall Place. Right-turning drivers exiting Blackhall Street may not anticipate northbound buses or taxis to proceed at the same time and potentially swing wide when turning right and encroach into the bus lane which could lead to an increased risk of side swipe collisions with northbound buses or taxis.

The problem will be further exacerbated should a taxi exit the side road and enter the bus lane at the same time as a northbound bus/taxi.

Turning manoeuvres out of Blackhall Street should occur on a separate phase to northbound buses to reduce the risk of collisions.

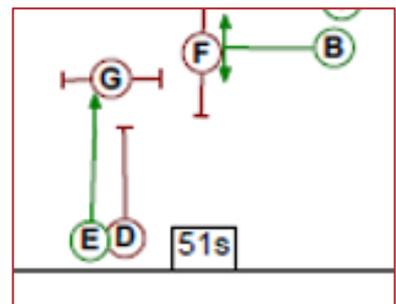
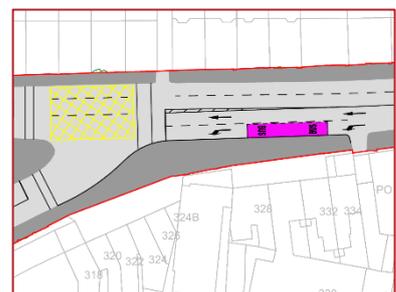
Location: Drawing no. BCIDC-ARP-GEO_GA-0005_XX_00-DR-CR-0036 (Rev. L01)

Summary: Proposed bus stop within the left turn lane upstream of the signalised junction on North Circular Road may result in conflicts between vehicles approaching the junction and buses exiting the bus stop.

A left turn and straight-ahead lane for westbound traffic has been indicated on North Circular Road on the approach to its junction with Cabra Road. An online bus stop has also been indicated within the left-turn lane upstream of the signals. Should a bus be stopped at the bus stop there is a risk that left turning drivers may attempt to take a rushed overtaking manoeuvre, particularly if the signals are green, leading to side swipe collisions with through traffic in the adjacent lane.

Also, it is unclear if the bus route at this location continues straight through the junction onto Cabra Road or turns left to continue on North Circular Road. If the bus route continues straight ahead buses exiting the bus stop may conflict with vehicles entering the left turn lane, or potentially be unable to enter the through traffic lane should there be a queue of vehicles in the adjacent lane during a red signal.

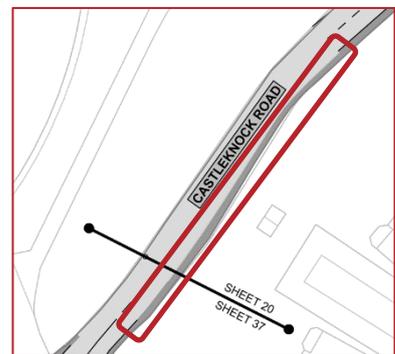
Summary: Footpath on the western side of Castleknock Road is narrow and may not be sufficiently wide enough to cater for opposing pedestrians.

The footpath indicated on the western side of Castleknock Road is very narrow and may not be sufficiently wide enough to accommodate opposing pedestrians. This could lead to pedestrians having to step into the carriageway to avoid oncoming pedestrians where there is an increased risk of being struck by a vehicle.

The footpath at this location should be a minimum of 1.8m wide.

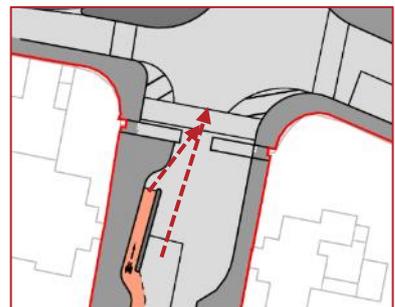
Summary: Risk of conflicts between cyclists and vehicles exiting the Phoenix Park at the proposed signalised junction of Castleknock Road and Blackhorse Avenue.

It is proposed to signalise the existing junction of Castleknock Road, Blackhorse Avenue and the Phoenix Park Ashtown Gate. Information regarding the proposed signal phasing for this junction has not been provided and it is therefore unclear if cyclists and vehicles will exit the Phoenix Park during the same phase. There is a pinch point at the Phoenix Park gate and if these movements were to occur during the same phase there is a risk of cyclists being squeezed by vehicles as they exit the park and potentially being struck.

Either provide separate phases should be provided for cyclists and vehicles exiting the Phoenix Park, or ensure that there is adequate width for cyclists and vehicles to safely exit simultaneously.

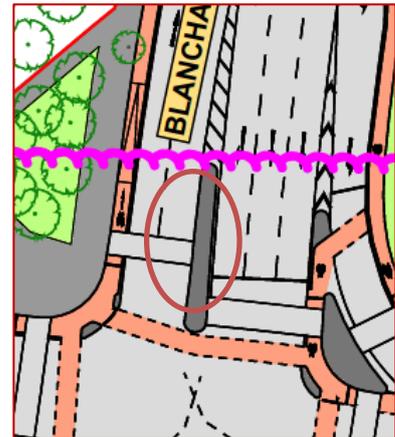
Summary: It is unclear if there is sufficient space within the central refuge island for a pedestrian to wait safely.

The proposed refuge island on the eastern arm of the R121 Blanchardstown Road South junction with the Navan Road appears to be relatively narrow. It is therefore unclear if there will be sufficient space for pedestrians, particularly wheelchair users and those pushing strollers, to wait within the island during the two-stage crossing. If the island is insufficiently wide enough for the expected volumes of pedestrians to wait there is an increased risk of pedestrians waiting in close proximity to, or stepping into the, traffic lane increasing the risk of being struck by a vehicle.

Ensure the island can accommodate the expected pedestrian volumes using the crossing and that it is sufficiently wide to accommodate wheelchair users and pedestrians with strollers.

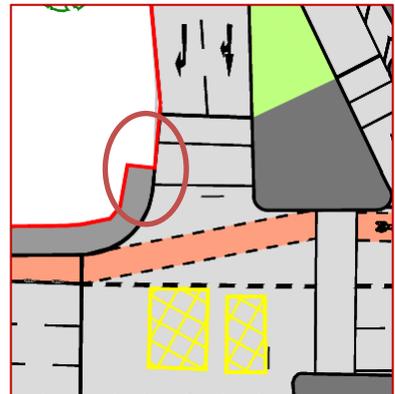
Summary: The footpath does not extend across the full width of the pedestrian crossing.

A pedestrian crossing is indicated across the N3 off-slip on the south-eastern arm of the R121 Blanchardstown Road South junction with the N3 northbound off-slip. The footpath on the northern side of the crossing is indicated as terminating in the middle of the proposed crossing. This may lead to pedestrians, particularly the mobility and visually impaired, being unable to access the crossing, or footpath, resulting in them continuing within the carriageway where there is an increased risk of being struck by a vehicle.

Extend the footpath across the full width of the crossing.

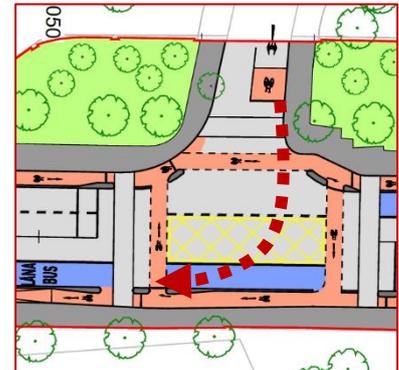
Summary: A sufficient gap has not been provided within the cycle track kerb to allow cyclists to turn right from side roads into the cycle track.

At three-arm signalised junctions along Navan Road the kerb adjacent the cycle track is indicated as continuous opposite the minor arm of the junction. Cyclists turning right out of the minor arms, from the advance stop lines indicated, will be unable to safely enter the cycle track leading to them having to continue within the traffic lane where they are at an increased risk of being struck by a vehicle or traversing the kerb resulting in falls from their bicycle.

Provide a sufficiently sized gap in the cycle track kerb opposite side road junctions to allow right-turning cyclists to safely enter the cycle track.

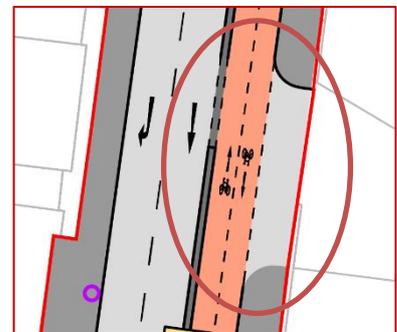
Summary: Gap in kerb at carpark entrance/exit does not extend across the full width of the access.

It is proposed to provide two-way cycle lanes along the eastern side of Queen Street, with kerbs indicated to segregate the cycle lanes from the adjacent traffic lane. An existing car park structure is accessed via Queen Street at this location. A gap has been indicated in the kerb however it does not extend across the full width of the access. This may lead to cars having to mount the kerb when entering/exiting the carpark increasing the risk of material damage collisions or to drivers attempting to enter/exit via the narrow gap indicated increasing the risk of low speed head-on collisions.

The gap in the kerb should be extended across the full width of the carpark access.

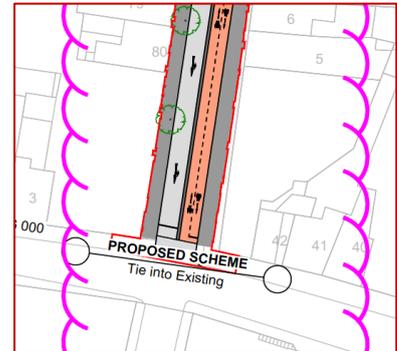
Summary: Unclear how cyclists in the proposed two-way cycle lane will access existing cycle facilities on Arran Quay.

It is proposed to provide a two-way cycle lane along the eastern side of Queen Street. The two-way cycle lane commences/terminates at the Queen Street / Arran Quay / Liam Mellows Bridge / Ellis Quay signalised junction. There are existing cycle lanes along the southern side of the North Quays at this location however it is unclear how cyclists will safely transition between the existing and proposed facilities. This may lead to cyclists attempting to travel between the cycle facilities on Queen Street and the Quays when it is unsafe to do so resulting in an increased risk of conflicts with other road users.

Provide separate signal phases for cyclists to access adjacent cycle facilities at this junction.

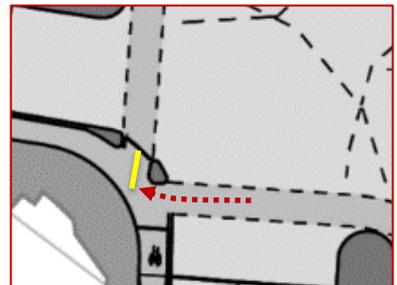
Summary: Right-turning cyclists may block straight through cyclists at signalised junctions.

It is proposed to provide protected cycle lanes at a number of signalised junctions within the Scheme. However, it is unclear from the drawing if there will be sufficient space at stop lines to allow cyclists to wait outside the path of an adjacent cyclist. Should there be insufficient space for a cyclist to pass a stationary cyclist, there is a risk of collisions between cyclists or to cyclists entering the carriageway, to pass a stationary cyclist, at locations where drivers may be less attentive to a cyclist entering the carriageway increasing the risk of collisions.

Ensure sufficient space is provided at cyclist stop lines for a stationary cyclist to wait out of the path of an oncoming cyclist.

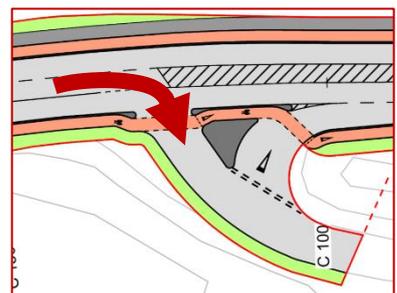
Summary: It is unclear if there is sufficient space within the junction to accommodate the swept path of right-turning HGVs entering the N3 on-slip.

It is proposed to amend the layout of the existing junction of the N3 on-slip and the Old Navan Road. The amendments would include the provision of a dedicated left-turn lane for northbound traffic with this manoeuvre having to give way to traffic turning right into the on-slip. It is unclear if there is sufficient space within the junction to accommodate the swept path of large vehicles from the right-turn lane. If sufficient space is not provided to accommodate right-turning vehicles there is an increased risk of them mounting the splitter island when turning and striking cyclists in the cycle lane.

Ensure that the swept path of large vehicles can be accommodated when turning right at this junction.

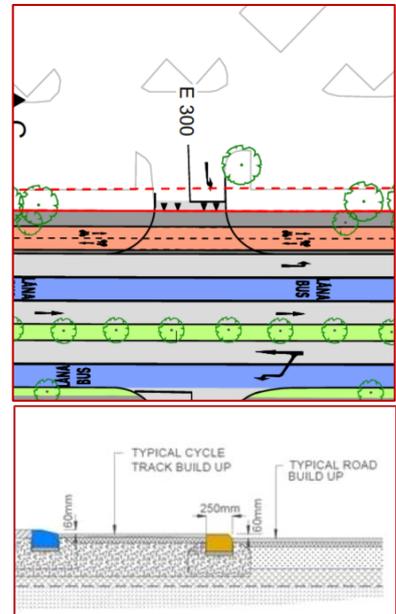
Summary: Height, and type, of the proposed kerb at the entry to the car park may result in difficulties for motorcyclists when traversing the kerb leading to loss of control.

Continuous segregated cycle and pedestrian facilities have been indicated across the carpark access into the Blanchardstown Shopping Centre with a change in level provided between the footpath and cycle track and cycle track and subsequently the cycle track and carriageway. It is proposed to provide a 60mm high kerb between the carriageway and the cycle track and a 60mm high kerb between the cycle track and footpath. Whilst both kerbs are splayed, the kerb between the carriageway and cycle track has a more pronounced profile which may not be suitable for motorcyclists, and may increase the risk of motorcyclists experiencing difficulty when turning into the carpark, resulting in loss of control collisions.

Ensure the height, and type, of kerb proposed at both transitions is suitable for all motorised vehicles, especially powered two-wheelers, such that it will not result in loss of control collisions when entering the carpark.

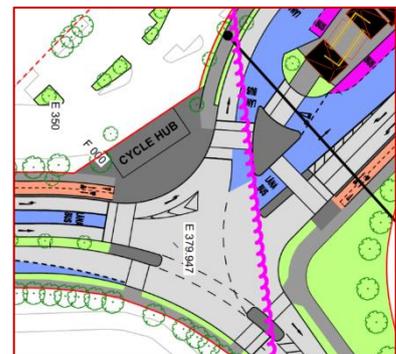
Summary: Unclear if there is sufficient space within the junction for right-turning buses.

The proposed signal phasing for the Bus Interchange West Access Junction in the Blanchardstown Shopping Centre permits right and left turning movements out of the bus lane. However, it is unclear from the drawings provided if there is sufficient space within the junction to accommodate the swept path of a right turning bus, or if this manoeuvre can be easily undertaken within the layout of the junction. If sufficient space is not available to accommodate right and left turning buses within the junction there is an increased risk of buses mounting splitter islands or footpaths and material damage.

Ensure all proposed movements from the Bus Interchange can be accommodated within the proposed junction layout.

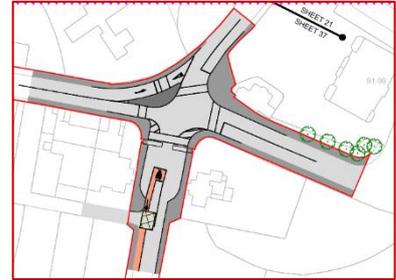
Summary: Drivers may continue to turn right from Castleknock Road should they consider the manoeuvre possible within the amended junction layout.

It is proposed to signalise the existing junction of Castleknock Road, Blackhorse Avenue and the Phoenix Park Ashtown Gate which is currently under priority-control. The proposed amendments also include restricting the western arm of the junction to left-turn only when exiting. The proposed amendments to the junction layout however appear to physically accommodate right-turns from Castleknock Road despite the left-turn arrow indicated which may not be adhered to by drivers who consider right turns possible at the junction. This may lead to drivers from Castleknock Road, who wish to enter the Phoenix Park or Blackhorse Avenue, turning right at the junction when it is unsafe to do so resulting in collisions with traffic from opposing arms that may have a green signal.

The shape of the proposed island should be amended such that right turn manoeuvres from Castleknock Road will not be possible. A 'No Right Turn' sign should also be provided to supplement the road marking.

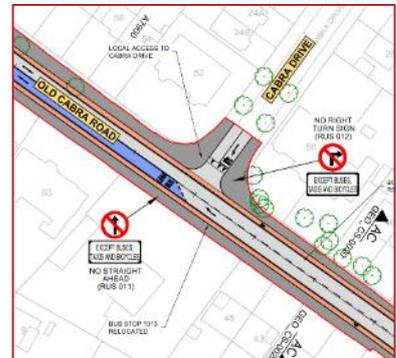
- 4.3 Residents exiting Cabra Drive at its junction with Old Cabra Road are prohibited from turning right where a northbound bus lane has been indicated. Drivers wishing to turn right from Cabra Drive are unlikely to turn left and follow a lengthy detour to reach their destination should it be north of Cabra Drive. This may lead to drivers not adhering to the restrictions and turning right when exiting Cabra Drive.

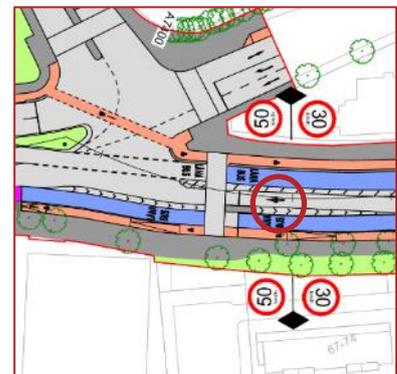
4.10 The arrow roadmarkings upstream of the stop line in the westbound lane on Old Cabra Road at its junction with Cabra Road and Ratoath Road contains a straight-ahead, left turn and right turn arrow. There is no side road located to the left of this lane at this location. The left turn arrow should be removed from the roadmarkings and a straight-ahead and right turn arrow only provided.

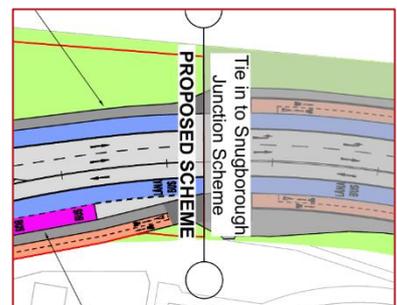
4.11 The L3020 is proposed to tie-into a separate scheme at the Snugborough Interchange. A two-way cycle track is indicated on the northern side of the L3020 within the adjacent scheme however it is unclear if measures will be provided for cyclists to access this facility from the facility on the southern side of the L3020 within this Scheme. Through liaisons with the Designers of the adjacent scheme, ensure a toucan crossing is provided on the L3020 linking the two cycle facilities.

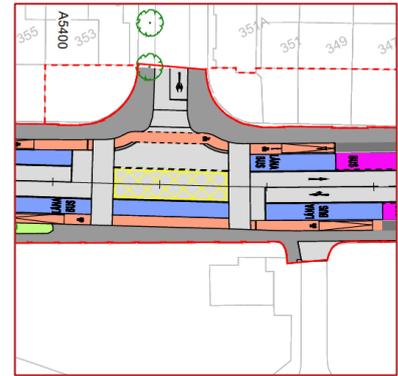
4.12 The access to the Daughters of Charity Disability Support Services on the southern side of the Navan Road is located in close proximity to the stop line at the signalised junction of the Navan Road and Ashtown Grove. The volumes of traffic entering/exiting this facility has not been provided to the Audit Team however if large volumes enter and exit this facility daily measures may be required (e.g. yellow box markings) to ensure drivers can safely enter and exit this access.

Alternatively, this access should be closed and access/egress to the Daughters of Charity Disability Support Services be provided from the other accesses further east and west of the junction.

The access is also located at a ramp in the cycle track which may lead to discomfort for drivers when entering should they have to mount a kerb at the ramp. The cycle track should be amended to remove the ramp from in front of the access

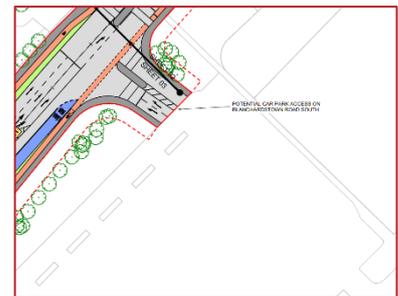
4.14 A new signalised access to the car park at TK Maxx in the Blanchardstown Shopping Centre from Blanchardstown Road South has been indicated. While the Audit Team have not raised any safety issues with the provision of the access in principle, if this access is included as the design progresses, ensure the approach through the existing car park is such that parked vehicles will not impede vehicles entering and exiting via this access.

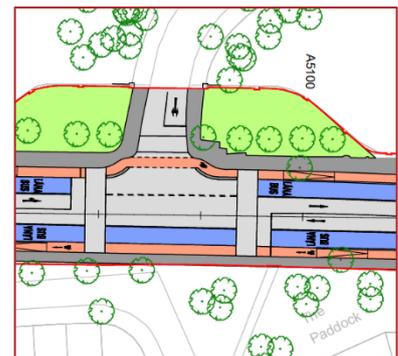
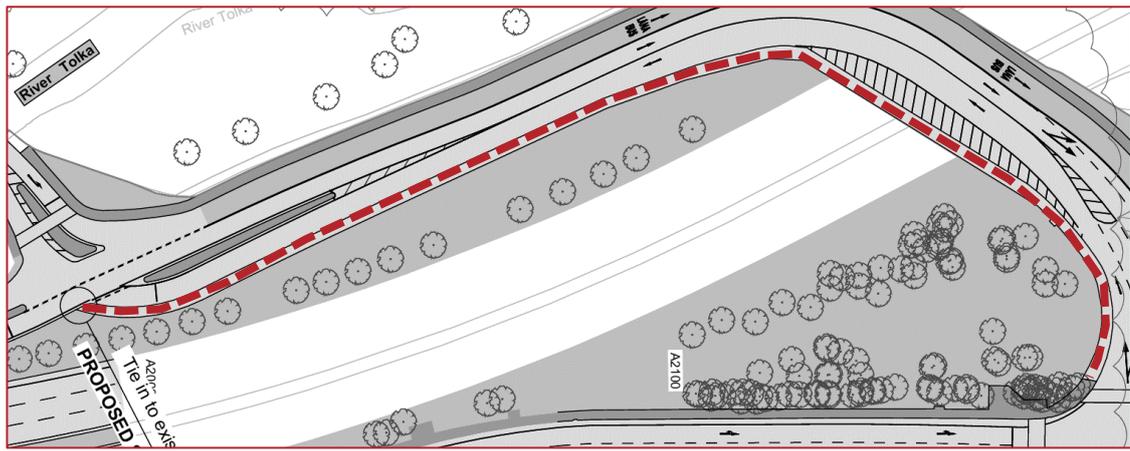
4.15 It is unclear if right turns will be permitted from the Navan Road at its junction with Kempton Avenue. The arrow roadmarkings, and phasing diagrams, at this junction suggest that right turns will be prohibited. Kempton Avenue leads to a large residential development. The only access to this development is through this junction. It is expected that this development will generate a large number of turning manoeuvres daily especially during peak times. If right turns are prohibited at this location, drivers will be required to continue west and perform a u-turn at the downstream roundabout which may lead to the roundabout experiencing capacity issues. Right turns into Kempton Avenue should be permitted from the Navan Road as in the current junction arrangement.
