Stage 1 Road Safety Audit

BusConnects Core Bus Corridors
- Blanchardstown to City Quays

Document Ref: P20-138-PSW1-RP-001

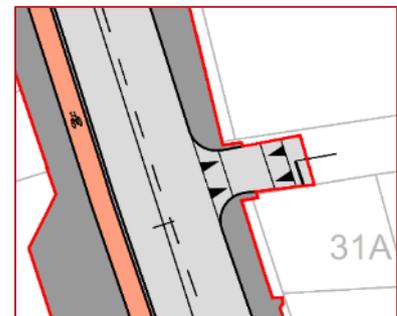
4.18 It is unclear if St Joseph's Place and Fingal Place can safely cater for two-way traffic at their junctions with Prussia Street.

Ensure adequate inter-visibility is available between a driver waiting at the stop line and a driver wishing to enter from Prussia Street so that one can wait and allow the other to exit before proceeding.

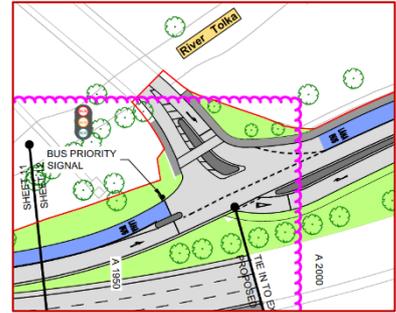
1. Yield road markings have been indicated for right turning vehicles at the Navan Road / Connolly Hospital Access signalled junction. Right turning traffic however is provided with a green signal on a separate phase and proceeds unopposed, resulting in the Yield symbol being redundant. It is assumed that this is CAD error and no Yield control will be provided at this location however the drawing should be amended and the Yield symbol removed.
