# **Appendix A17.1** Arboricultural Impact Assessment

# 1 Introduction

Arbor-Care Ltd (Professional Consulting Tree Service) was retained by ARUP Consulting Engineers on behalf of the National Transport Authority (NTA) to undertake an Arboricultural Impact Assessment, and a Tree Protection Plan identifying the trees, groups of trees or hedgerows that may be impacted on by the BusConnects Core Bus Corridor. The surveyed trees contained within this report are located within or adjacent to the proposed Blanchardstown to City Centre Core Bus Corridor (refer to Figure 1 on page 5 of this report) (hereinafter referred to as the 'Proposed Scheme'). The objective of the impact assessment was to identify the areas that contained trees, groups of trees or hedgerows, and to ensure where practicable that these areas would be retained, and to identify the trees that are to be removed to facilitate the Proposed Scheme.

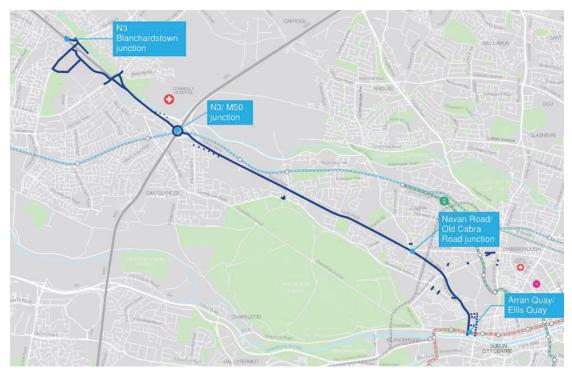
Figure 1: Proposed Blanchardstown to City Centre Scheme

From a new terminus to the north-west of Blanchardstown Shopping Centre the Proposed Scheme is routed onto the N3 Navan Road via the Snugborough Road junction and follows the N3 and Navan Road as far as the junction with the Old Cabra Road. From here, the Proposed Scheme is routed along Old Cabra Road, Prussia Street, Manor Street and Stoneybatter to the junction with King Street North. The core bus corridor is then routed via Blackhall Place as far as the junction with Ellis Quay, where it joins the prevailing traffic management regime on the North Quays. At the Stoneybatter / Brunswick Street North junction, cyclists proceed along Brunswick Street North, George's Lane and Queen Street as far as Ellis Quay/Arran Quay. Refer to Figure 1.

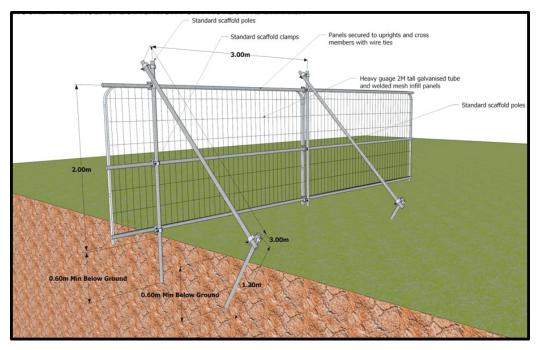
Figure 4: Default specification for tree protection barrier in accordance with BS5837:2012 figure 2.

Fencing shall be constructed with robust vertical and horizontal scaffold framework with weldmesh panels firmly attached in accordance with BS 5837:2012 Figure 2. Vertical support poles and bracing poles must be located with care to avoid underground utility services and will be sited to avoid the structural roots of retained trees. Where driven supports are not practicable due to the presence of roots or underground utilities block trays, counterweights or equivalent can be utilised.
